Cocos (Keeling) and Christmas Island, Sign & Pavement Marking Corrective Report

June 2019

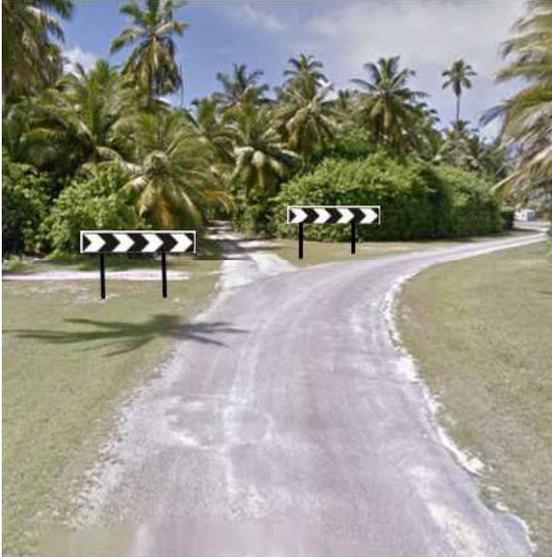
1. Northern end of Sydney Highway veers to the right (to access the fuel storage facility and old Jetty) but there is an access road that continues straight ahead which a tourist could inadvertently travel on. MR-HM-3 Hazard Markers should be placed adjacent to this access road to demonstrate the requirement to deviate to the right.

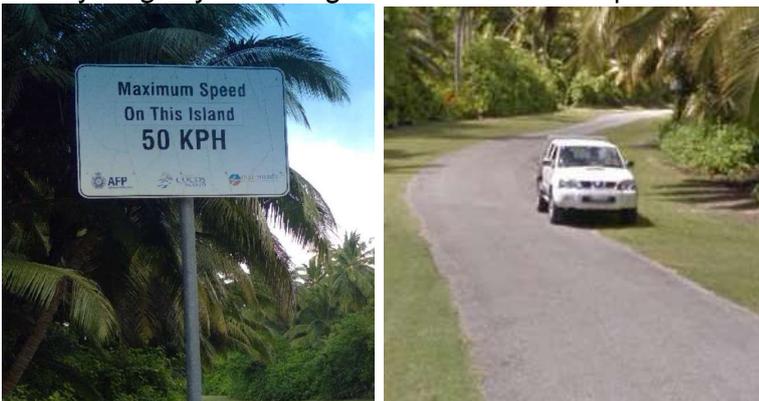
2. The validity of the “Maximum Speed On This Island 50 KPH” sign is questionable when you consider:

- Applicable speed limits for various road types can be seen within the Main Roads Speed Zone Policy at item 4.
- Much of the road seal is below the 5.5m required minimum to allow for formal speed zoning as defined within the Main Roads Speed Zone Policy at item 4.1.3.1.
- Many of the roads on the island are unsealed and as such cannot be speed zoned.
- There is no provision within the Road Traffic Code 2000 which supports this sign.
- This sign is not a standard sign from Australian Standards or Main Roads Standards.

Even if the use of the sign could be successfully argued, the position of the sign is poor as it is at the very Northern end of the island (possibly now redundant as a remnant sign from when the old jetty was operational).

There is another sign replicating this one on Sydney Highway as you head North away from the Settlement just past Alexander Street, the same points made above apply to this sign also.

My recommendation is that advice be sought from the State Solicitors Office to determine the validity / legality of this sign and its intended impact.

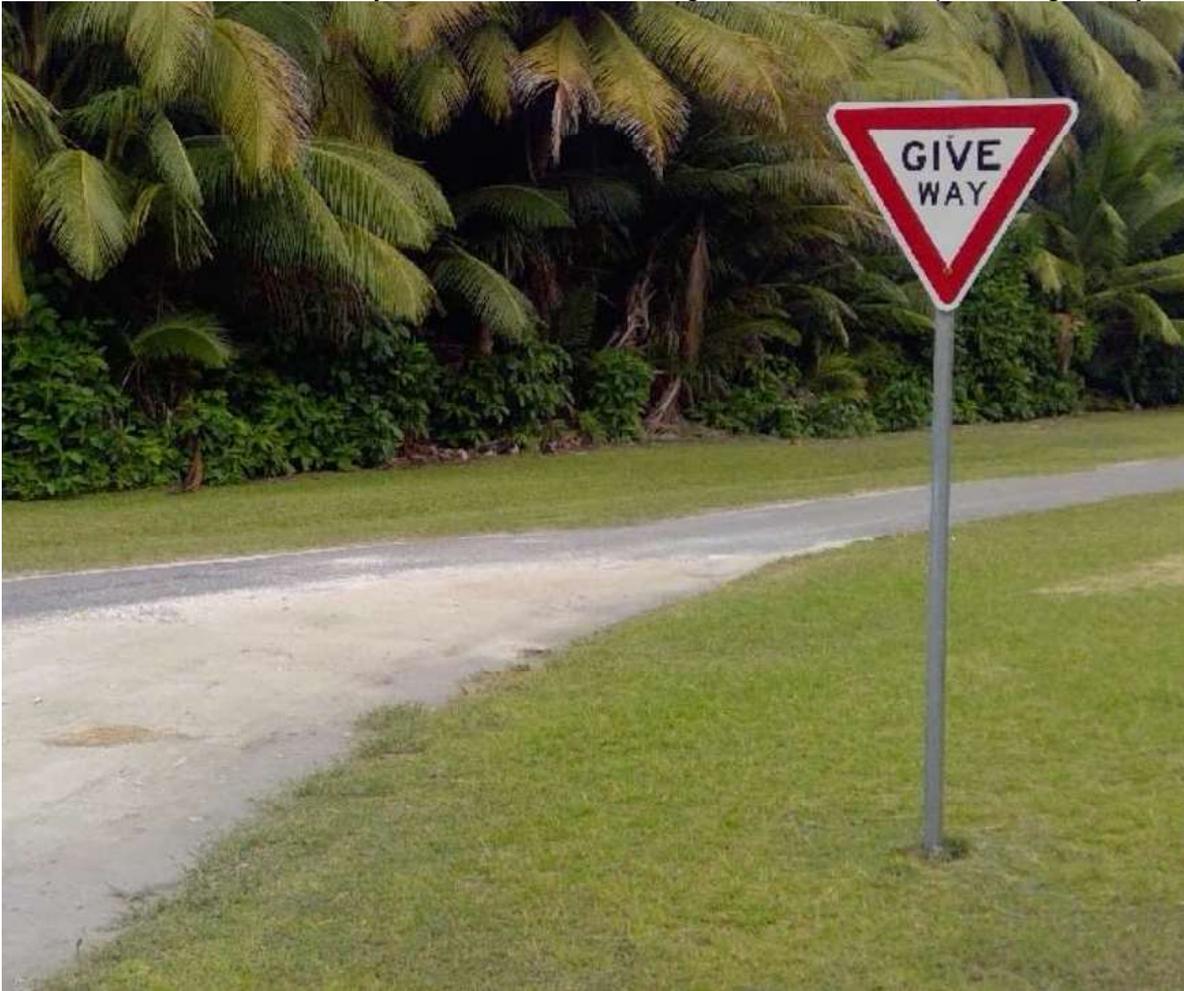
3. Give Way sign on Heart Break Drive (access track to Trannies Beach) where it meets Sydney Hwy is on the wrong side of the road (is on the right, should be on the left) but given the nature of the intersection the Give Way could be removed altogether without compromising safety.

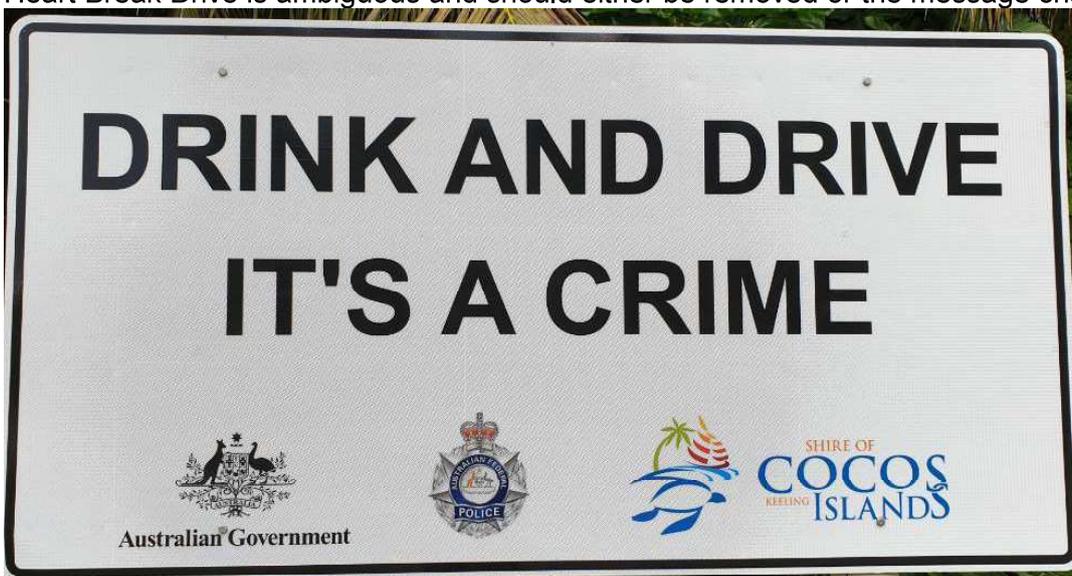
4. Road Safety Message sign “DRINK AND DRIVE IT’S A CRIME” which is on the verge opposite Heart Break Drive is ambiguous and should either be removed or the message changed.

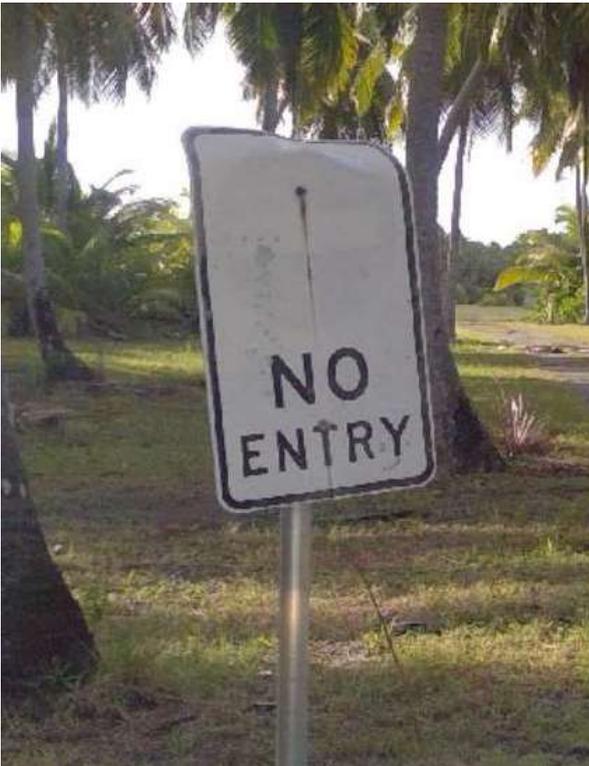
5. No Entry sign at access track on Sydney Hwy is in very poor condition and is of an old standard. This needs to be replaced with the current R2-4 No Entry sign.

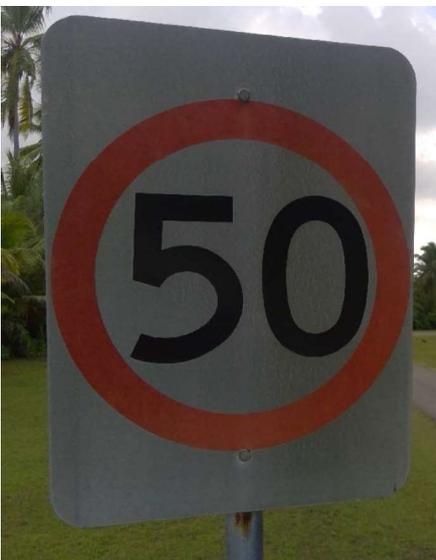
6. Formal 50 Km/h Speed Zone signs across the island are typically in poor condition and often obscured by vegetation. Signs showing a 50 Km/h speed limit should not be used in built up areas where the operator of a motor vehicle should be aware of their obligations under the Road Traffic Code.

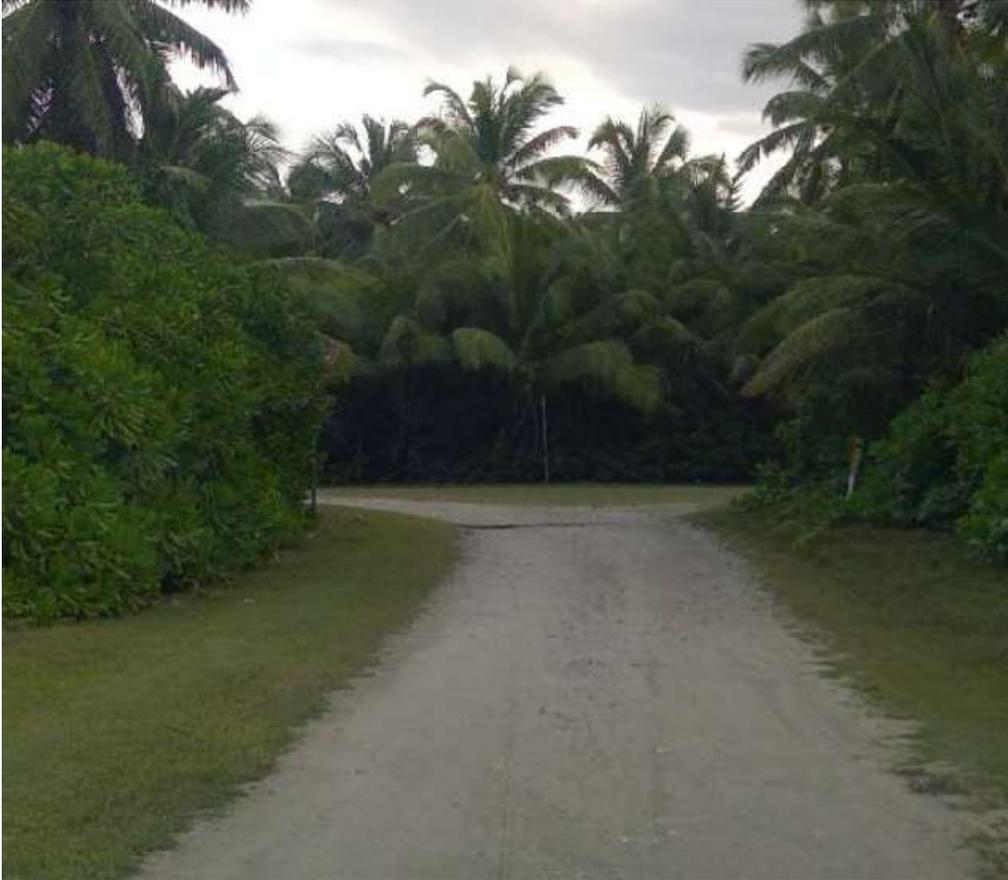
7. On Mahoon Road at Sydney Hwy vegetation has obscured the Give Way sign and a [MR-HM-2](#)

should be installed opposite the intersection. Mahoon Road is the access to the tourist destination “The Farm Shop” where local produce is available and tours of local farming techniques is available, the installation of a Tourist destination sign should be considered.

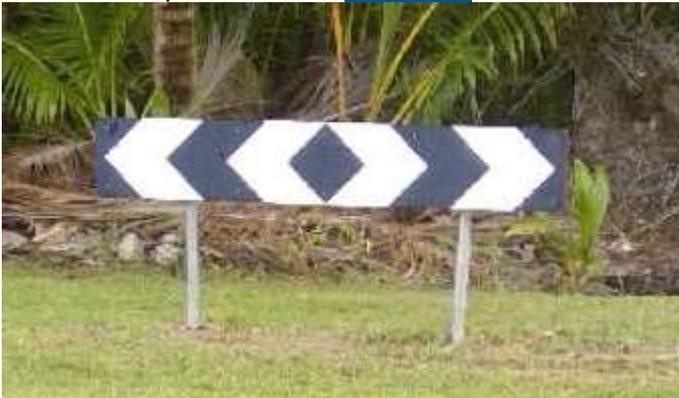
8. On Sydney Hwy opposite Rumah Baru Road (access to the Ferry) there is a [MR-HM-1](#) which should be replaced with a [MR-HM-2](#)

to bring it up to standard.

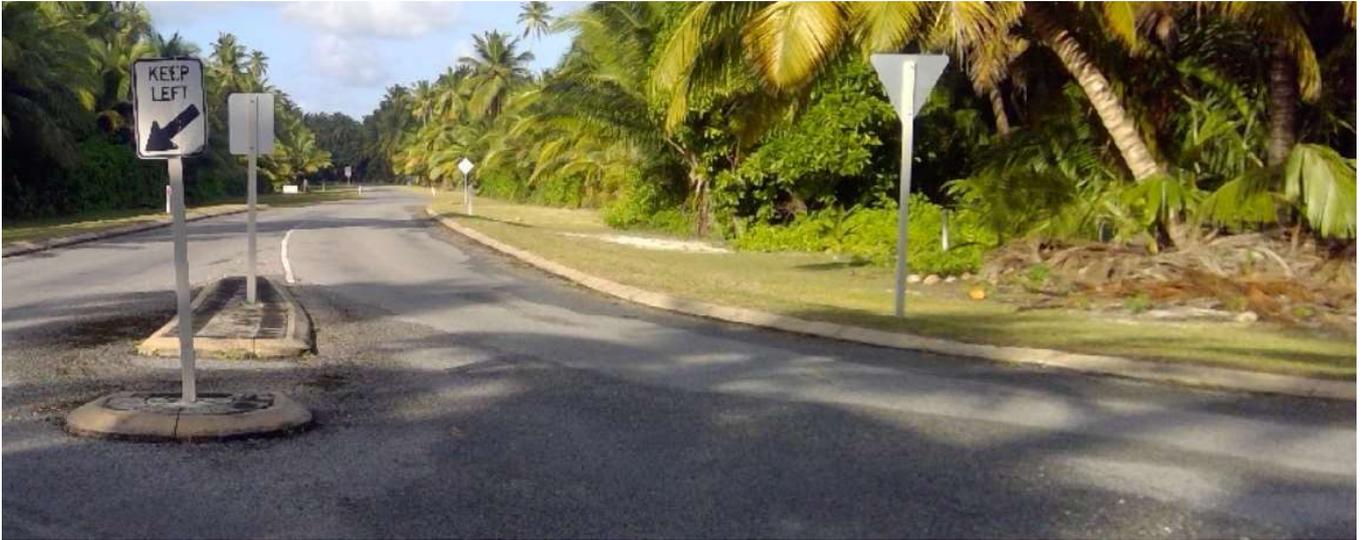
9. Along the median island on Rumah Baru Road at Sydney Hwy the Keep Left signs have excessively long posts on them. Given the low volume of vehicles which utilise this intersection I don't think a raised island with signs is required, a painted island could be installed but this may also be excessive and just a length of Separation Line to define the centre of the road would suffice. This intersection has a formal Give Way Sign but no Give Way line. Whilst a line can be installed without a sign, a sign cannot be in place without a line, as such a Give Way line needs to

be installed. If the raised island is to remain then the Give Way sign on the verge should be relocated to the nose of the island and both Keep Left signs removed to align with Main Roads [standards](#)

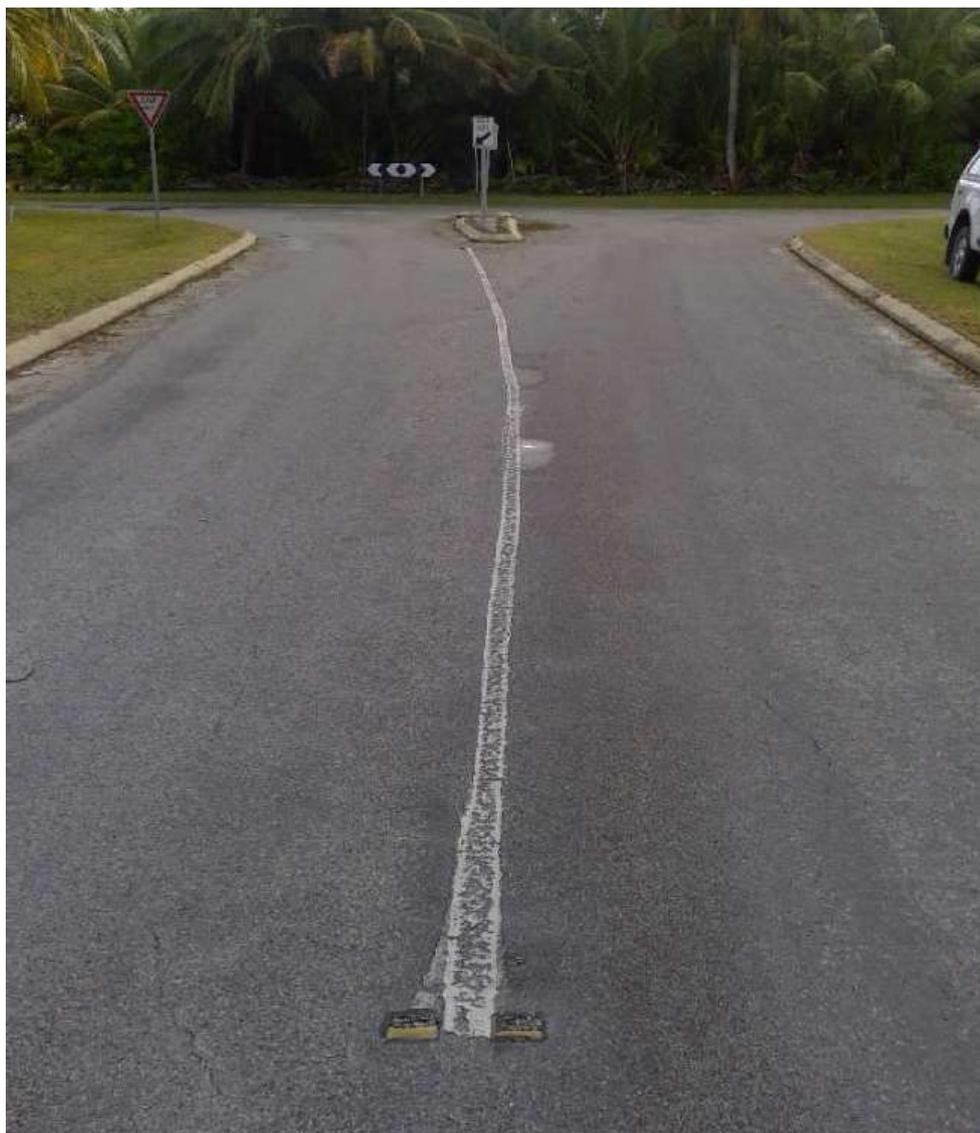
Additionally, the linemarking to the island is incorrect and should be changed to reflect current standard as demonstrated on standard drawing [200331-0184](#)

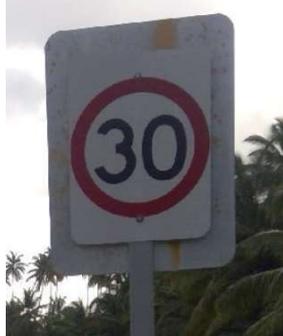
10. On Rumah Baru Road approximately 170m East of Sydney Hwy there is a 50 Km/h sign on the Northern verge for road users travelling East with a 30 Km/h sign panel on the back of it. The 30 Km/h sign should be removed as speed zone signs are not used on approach to a terminating road to slow traffic, other measures such as Give Way Ahead Warning sign should be considered.

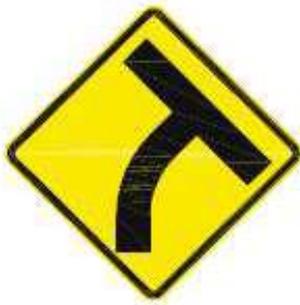
11. Just prior to the end of Rumah Baru Road where the ferry carpark exists there is a 20 Km/h sign, this is not required and is not supported by the Main Roads Speed Zoning Policy, the termination of the road and change of environment is self-evident resulting in a natural reduction in approach speed.

This sign should be removed, if it is felt that advanced warning is required then warning sign W2-14(R) could be installed in its place.

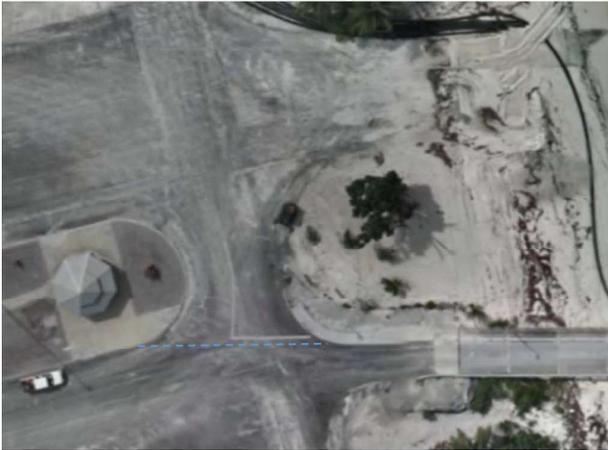
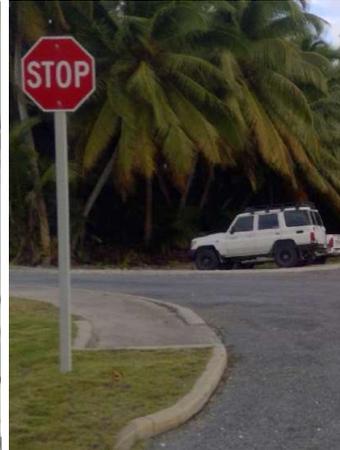
12. At the end of Rumah Baru Road immediately prior to the jetty the carpark expands to the North allowing access to a boat ramp. This area is divided from the main ferry carpark by an isolated Stop Sign, this is the wrong application for a Stop Sign and the warrants for installation are not met. If it is felt that formal separation of the two areas is required then a length of Continuity Line could be installed, but assessment of the geometry on site is that safety is not compromised by having this area without signs and lines.

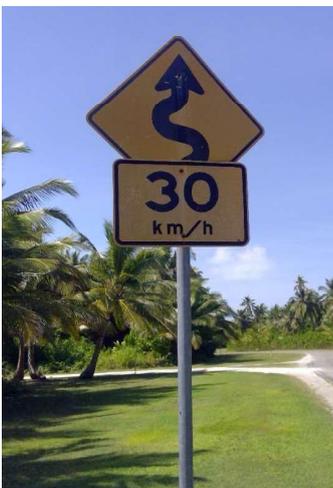
13. On Sydney Hwy just north of the Transfer Station, there is a curve warning sign with a 30 Km/h advisory speed tag. The tag is obscuring the warning sign and needs to be lowered plus both panels are in poor condition.

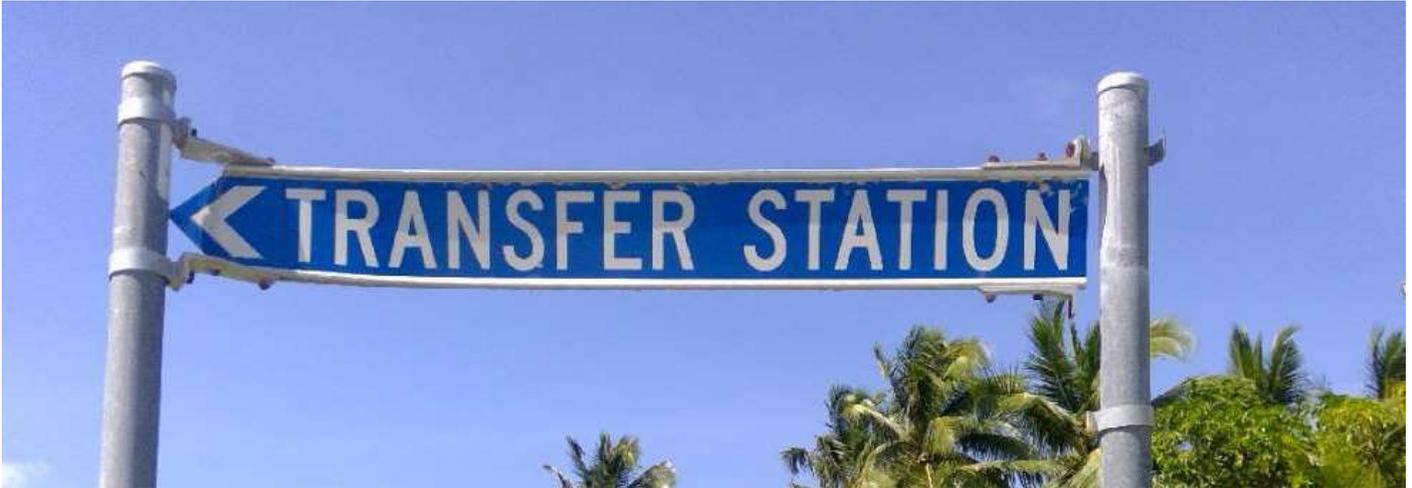
14. At the entrance to the Transfer Station, the Transfer Station Service sign requires maintenance, the fixing has broken away from one pole and the sign could potentially become a spear during extreme weather.

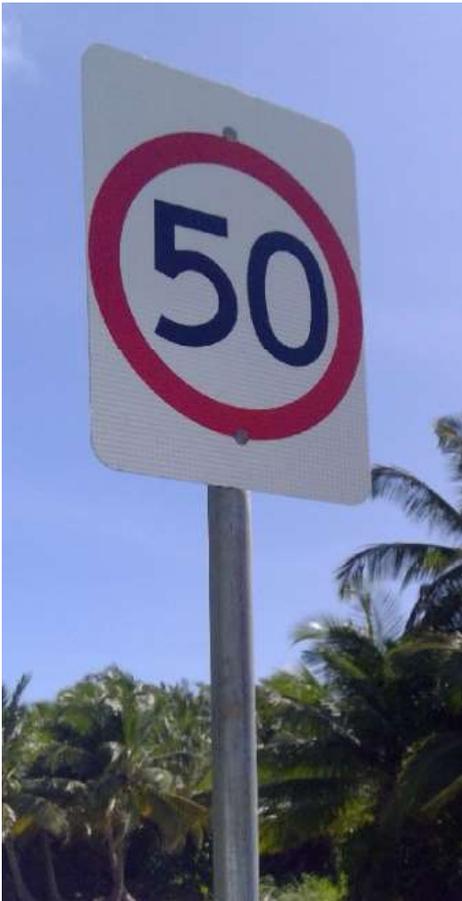
15. Just south of the Transfer Station access there is an “A” size 50 Km/h speed zone sign, the standard size for repeater speed zone signs is “B”. More importantly, the sign is located within a series of curves, which are signposted on each approach with a 30 Km/h advisory speed. The inclusion of the regulatory 50 Km/h sign within this length of road creates confusion and should be removed. For further detail, refer to Australian Standard 1742.4-2008 Part 3.3 below;

3.3 CONFLICT WITH ADVISORY SPEED SIGNS

Advisory speed signs within any speed zone or default limit shall not show a speed greater than the speed limit. Speed limit signs and advisory speed signs showing different speed values from one another shall not be placed where drivers can read both at the one time or otherwise so close that they might appear to be conveying contradictory messages.

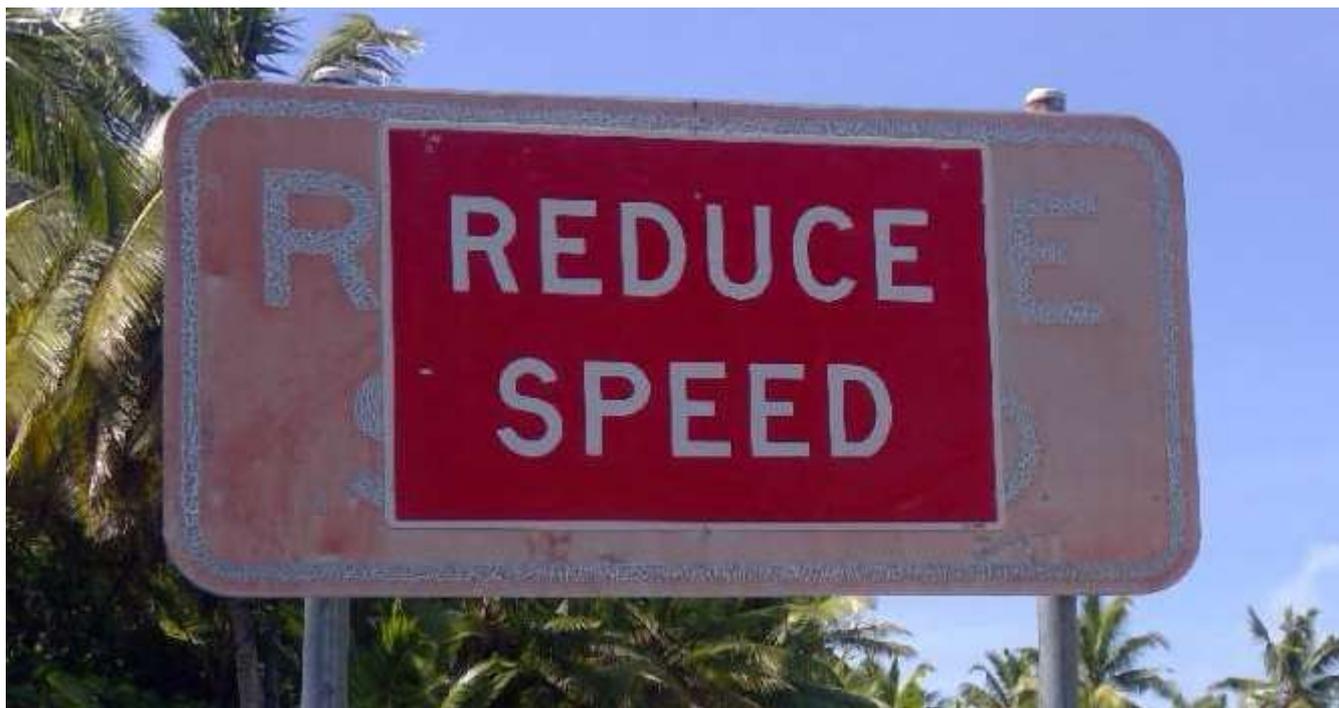
16. Just prior to the final curve in the series there is a “REDUCE SPEED” sign, which has been overlayed onto an older REDUCE SPEED sign, this should be removed altogether. Other than the reduction of the new signs effectiveness by being placed within an older sign panel, this sign is reserved for use for where a motorist has been travelling at high speed for a considerable time and approaches a significant speed reduction

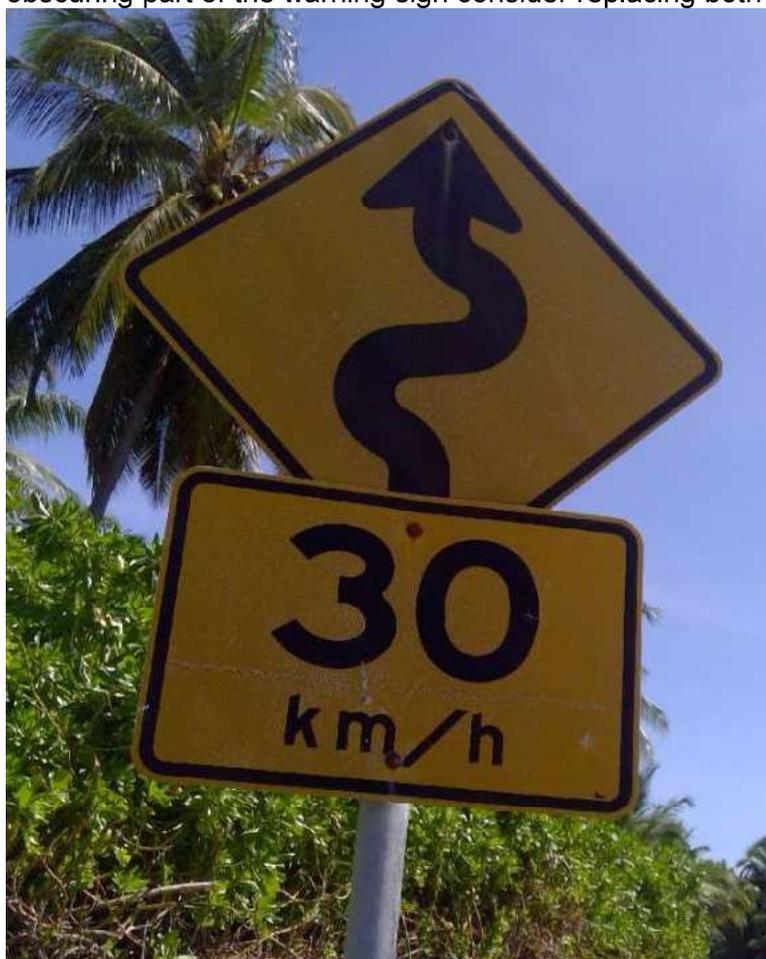
17. As with the complimentary sign on the other end of this series of curves, the combination of curved road warning sign with 30 Km/h advisory speed tag is in poor condition and the tag is obscuring part of the warning sign consider replacing both panels and install correctly.

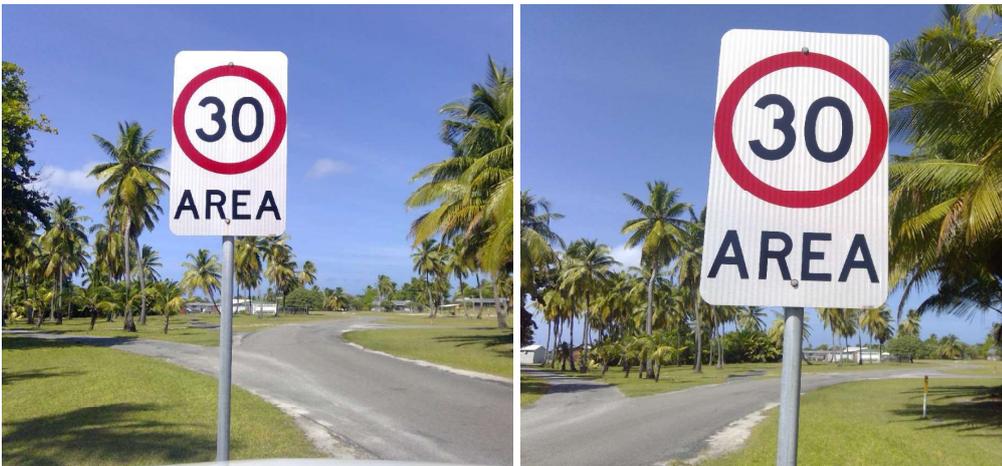
18. On Sydney Highway south bound just before Alexander St there are a pair of 30 Km/h AREA speed zone signs. At the time of the sign capture, the corresponding END 30 Km/h AREA on the reverse side of these panels for road users travelling north were missing, Google street view shows they were in place in February 2018 [here](#) . Whilst the signs have been used correctly and the intent to reduce vehicle speed around the settlement to improve road safety is understood, given the general environment on West Island and the limited number of vehicles operating on the network, are they really required?

Recommendation is that a 50 Km/h AREA be utilised across the sealed road network on the island. This would bring the settlement roads into line with all other built up areas and the “Maximum Speed On This Island 50 KPH” sign commented on at point 2. could then be removed. 50 Area signs would not be required within the settlement as it is built up, but would need to be installed at this location for North bound traffic exiting the built up area, AREA signs would need to be changed on Air Force Road where the End 30 AREA are currently installed.

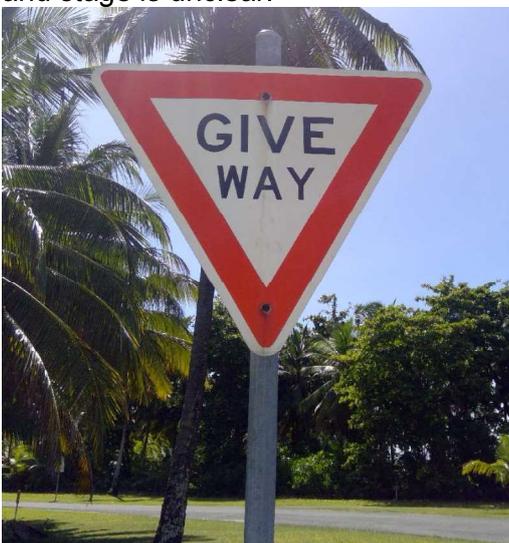
19. On Buffett Close at Sydney Highway, there is formal Give Way control. Local access roads in low speed environments do not need formal control as the requirement for motorists on the terminating road to yield to motorists on the through road is already covered under legislation within the Road Traffic Code 2000 (anyone with a driver’s license should be aware of their obligations). See Main Roads Policy on the use of Give Way signing [here](#).

There are many T junctions across the island that are under Formal Give Way control, recommendation is to remove the Give Way control if the intersection is a clear T-junction, but retain the Give Way line if the geometry of the intersection is such that the correct position to yield and stage is unclear.

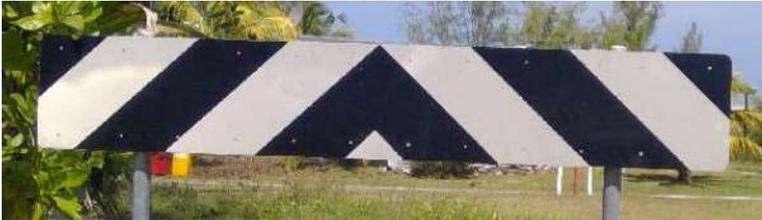
20. Buffett Close Cul-de-sac has a [MR-HM-2](#)

at the end of the road. These signs are used opposite T-junctions when there is not a development opposite. The correct sign to use at the end of a Cul-de-sac is a D4-5 Obstruction Marker; see Australian Standards 1742.2-2009 Part 4.6.7.2(d)

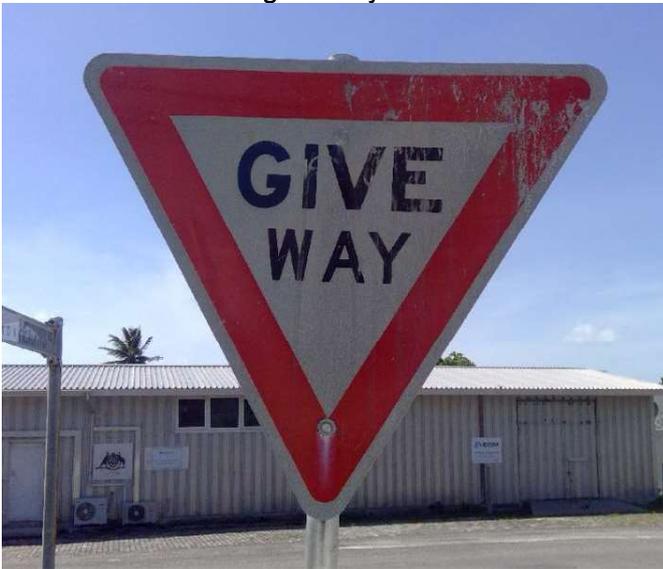
21. On Beacon Heights Road at Sydney Highway this T-junction has a Give Way sign in poor condition, as previously stated T-junctions that comprise of access roads within a low speed environment do not generally need formal control.

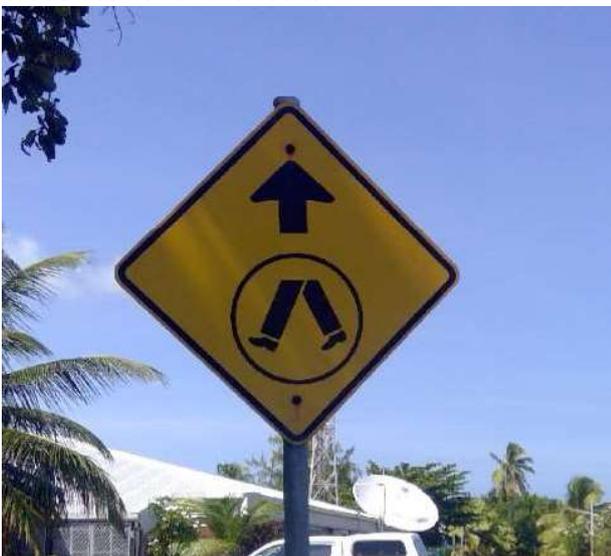
22. On Sydney Highway (Fremantle Road) just South of Emden Walk there is a Pedestrian Crossing Ahead Warning sign (W6-2B) which is used prior to formal crosswalks but there isn't a crosswalk over the road.

It is acknowledged that people cross the road at this location due to the Cocos Club and Tropicana being on either side of the road, the correct sign for this instance should be a

I also note that the Pedestrian Crossing Ahead warning sign (at the time of the pick-up) only existed north of the crossing location, a warning sign (W6-1) should exist on either side of this informal crossing point.

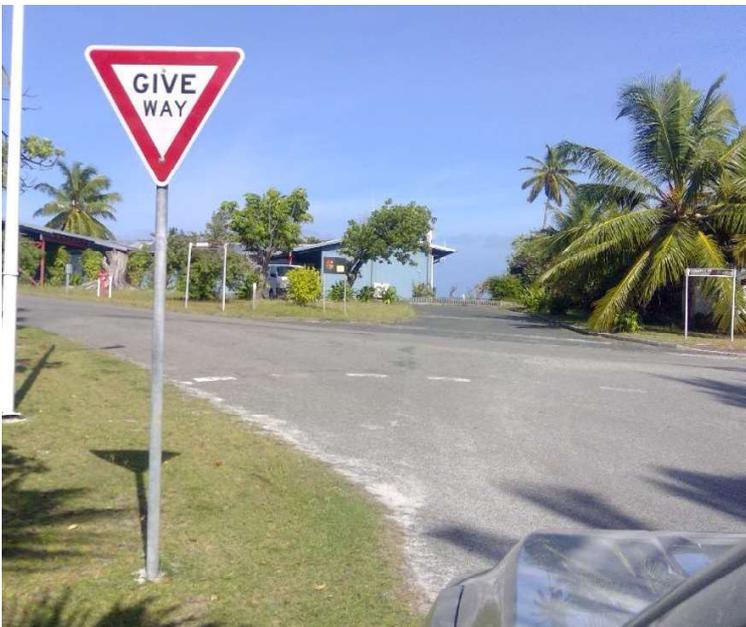
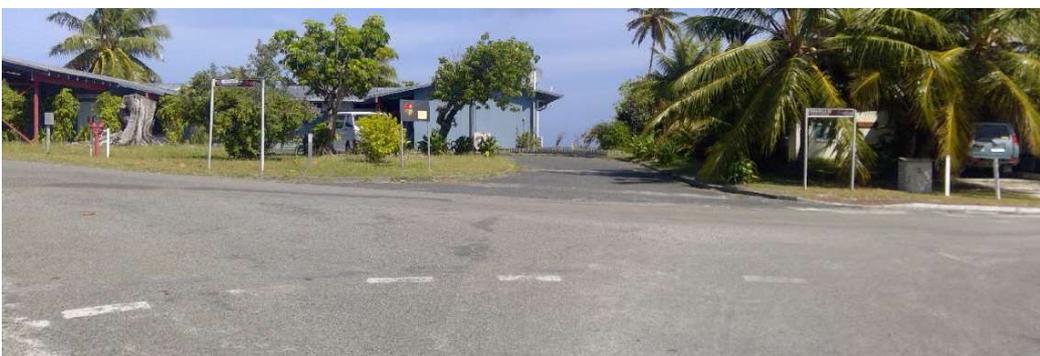
23. Clunies Ross Avenue where it meets Sydney Highway (Fremantle Road) – William Keeling Crescent is controlled by a Give Way sign, as there is a business driveway opposite this intersection it in effect turns the location into a 4 way intersection. As such the driveway should be under Give Way control as well.

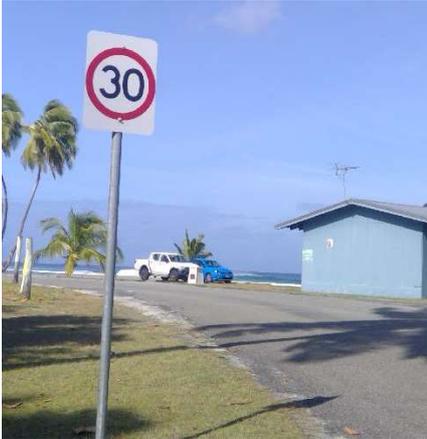
24. On William Keeling Crescent immediately south of Clunies Ross Avenue there is a 30 Km/h repeater sign. As this is a 30 Km/h AREA, this sign needs to be replaced with a 30 km/h AREA speed limit sign (or removed if recommendation at point 18 is adopted).

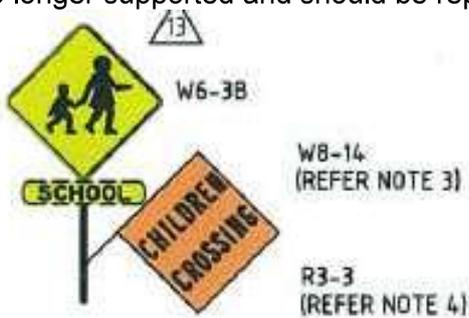
25. On Nelson Mandela Walk, south of Clunies Ross Avenue, there is a symbolic children's sign with school tag prior to the Cocos Island District High School. This sign is of an old standard that is no longer supported and should be replaced with a W6-3B and W8-14 tag.

Refer to standard drawing [9120-0174](#). This scenario is replicated at the other end of the High School.

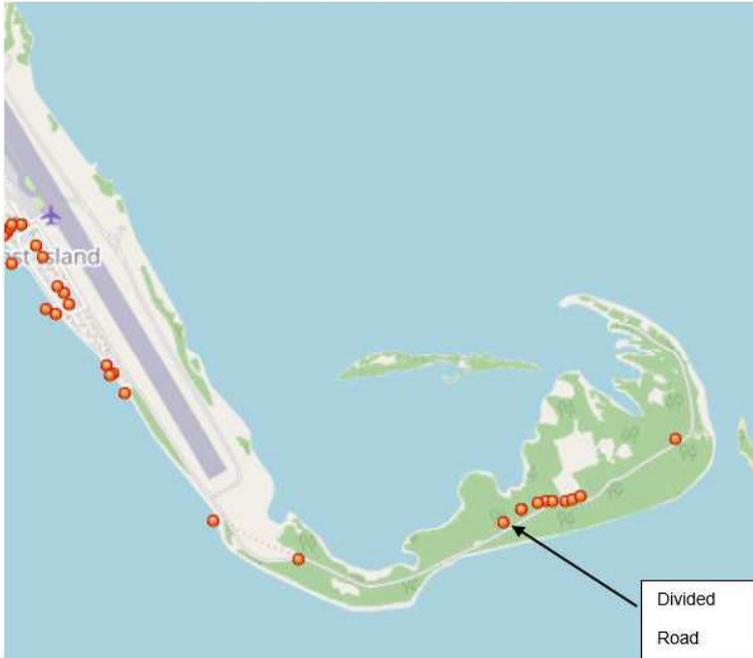
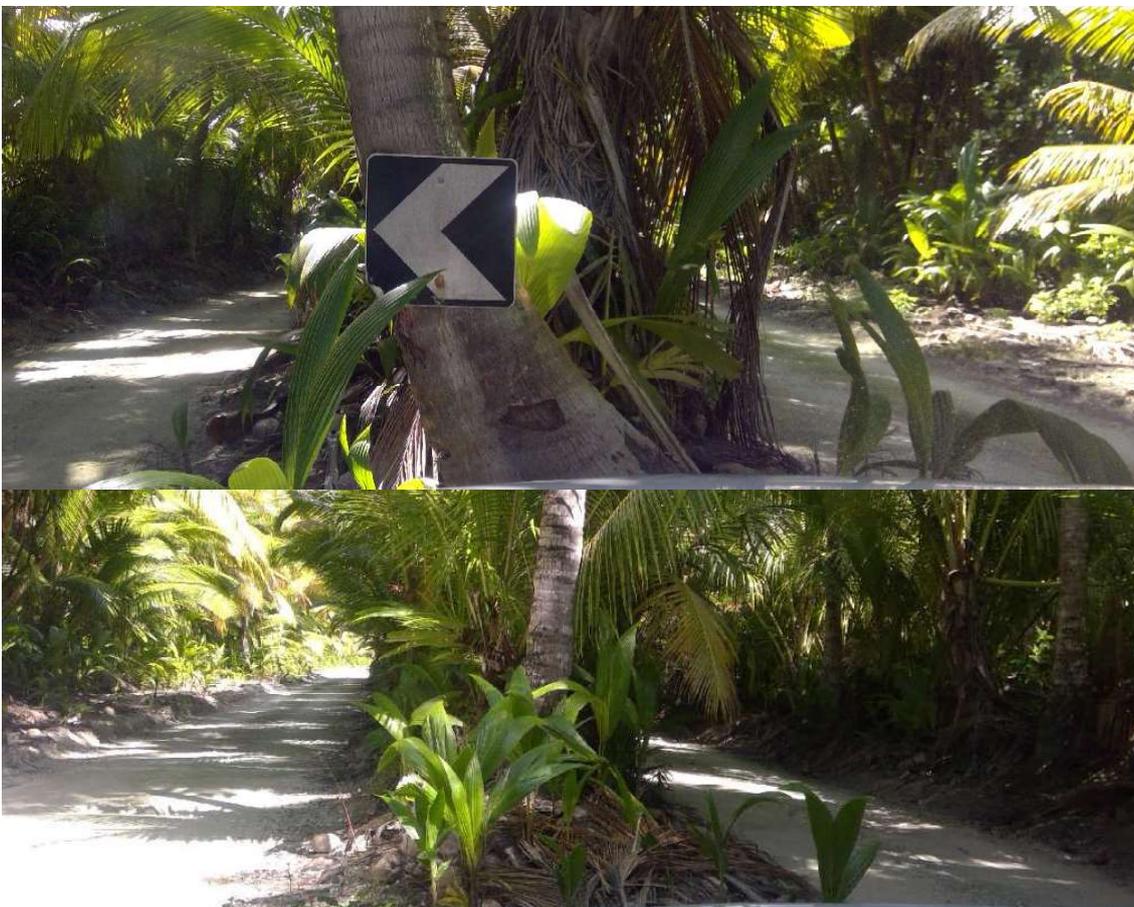
This section felt the most unsafe section of road on the island for a driver, especially at night. There is no street lighting and only a uni-direction Hazard Marker attached to a palm tree when approaching from the settlement to highlight the requirement to veer to the left. Approaching from the other direction there is nothing.

There is no clear reasoning for this anomaly in the middle of the road; if it is not required, my recommendation is that it be removed altogether.

If this cannot be done, then I propose that the existing advanced warning signs (W4-4)

be maintained to highlight the impending hazard ahead, and Keep Left signs should be installed at each end to reinforce the requirement to deviate to the left.

The ultimate treatment would be to have a reflective barrier around this median.

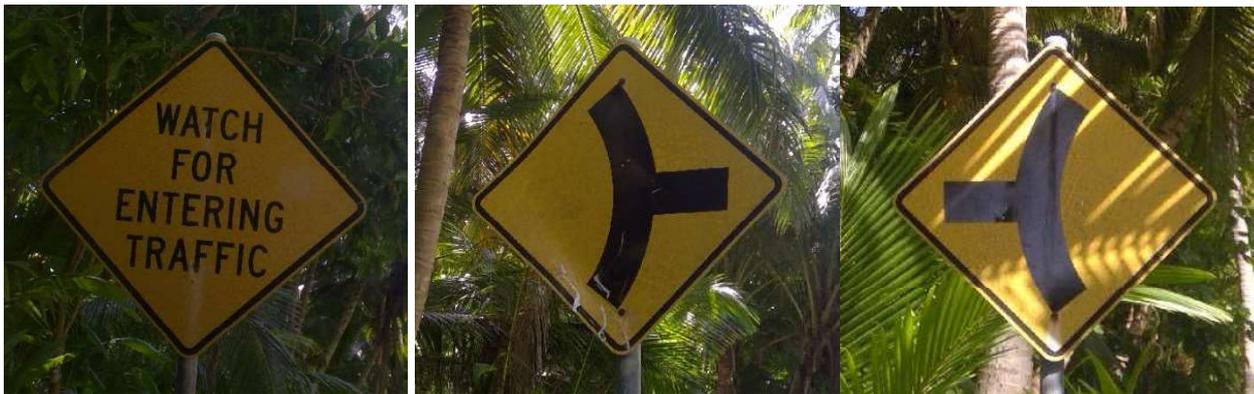
29. Immediately after this median treatment, there are a number of warning signs.

Given the sparsely populated island and little tourist traffic, these signs are unnecessary and don't provide any real safety improvement. Recommendation is to remove them completely.

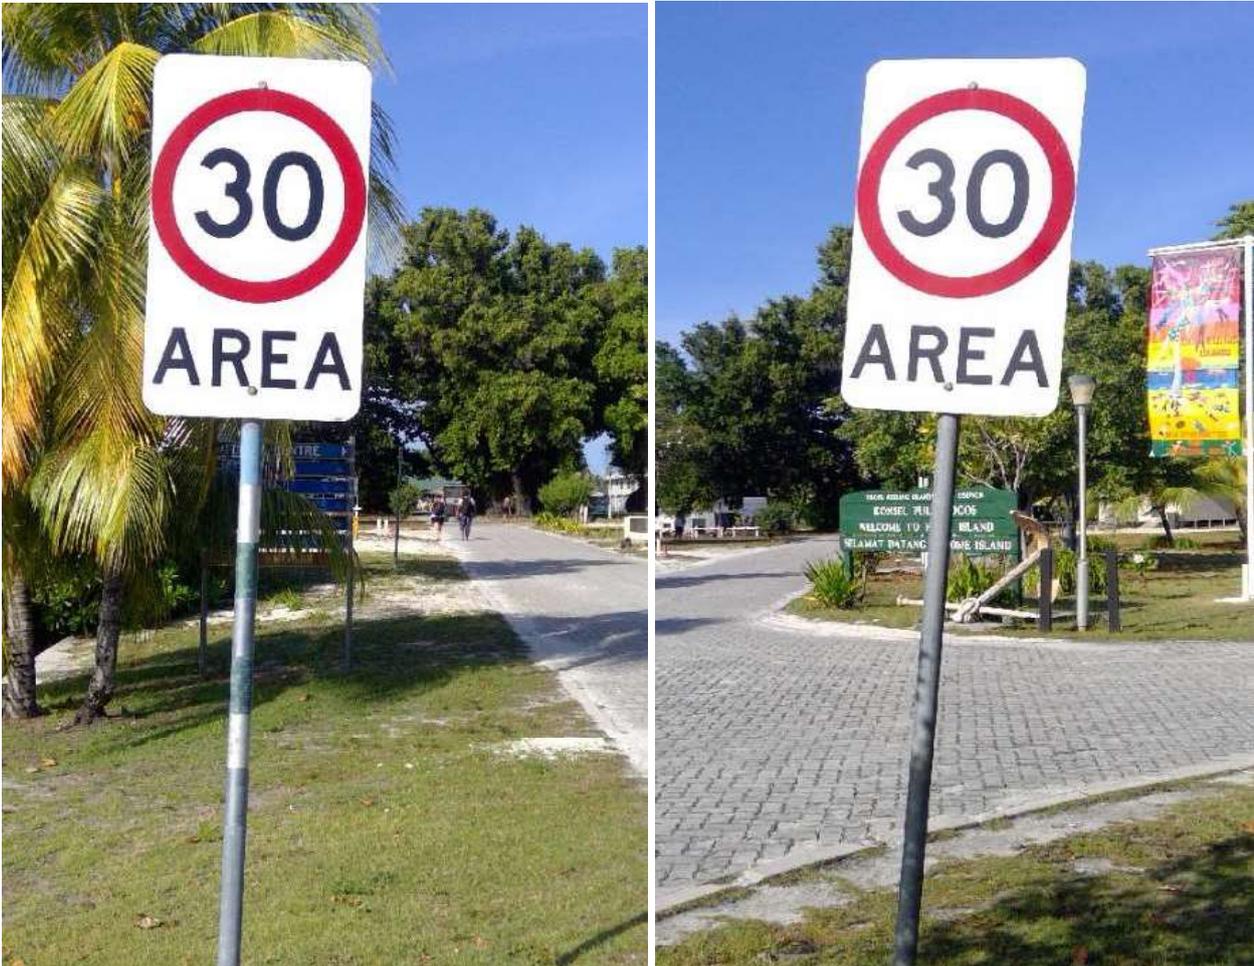
30. As you arrive on Home Island from the ferry terminal there are two 30 Km/h Speed Zone AREA signs, whilst the application of these signs is correct, their usefulness is queried. Given that there are very few cars on the island and the main mode of transport is on either foot or quad bike / buggy the low speed environment is self-governing. Additionally I suspect that formal approval for this AREA speed limit has not been sought or granted. Recommendation is that all the 30 Km/h AREA Speed Zone signs across the island be removed.

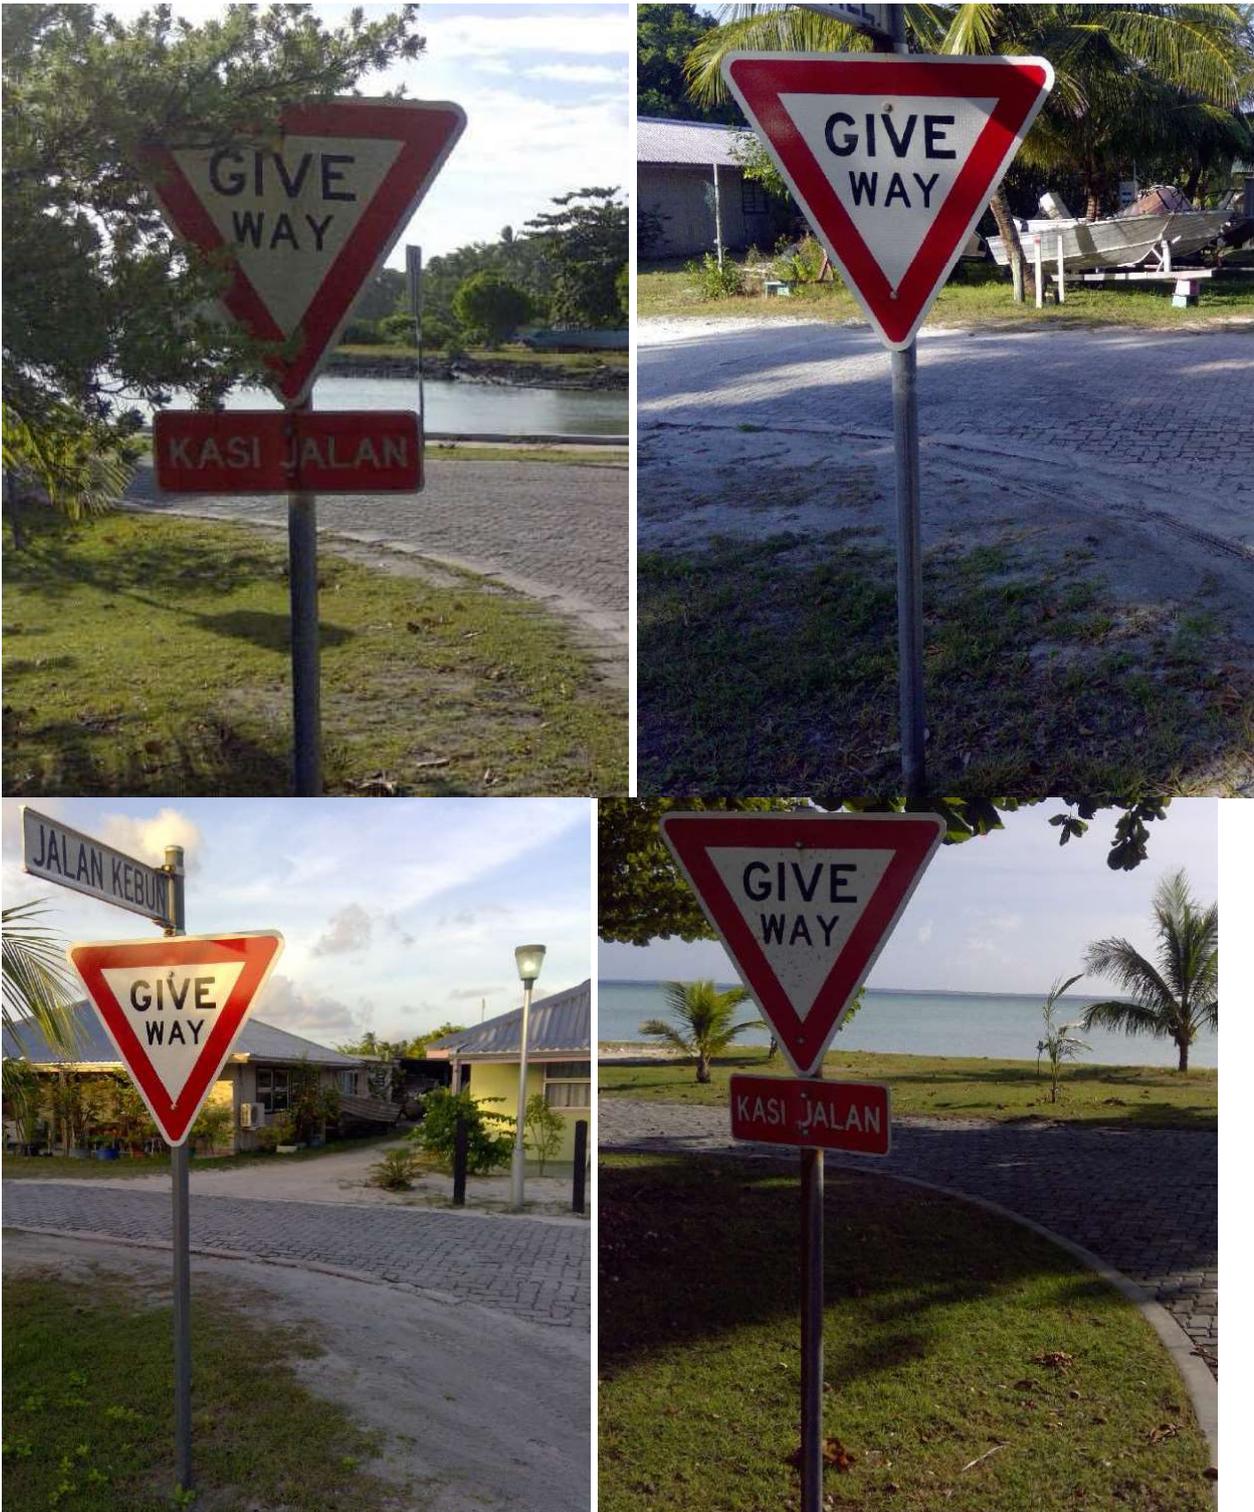
31. At many T-junctions across the Island there is formal Give Way control, this is unnecessary as formal control is typically not required at T-junctions. The requirement to yield to through traffic when on a terminating road is already covered by legislation within the Road Traffic Code. See Main Roads policy on the use of Give Way [here](#).

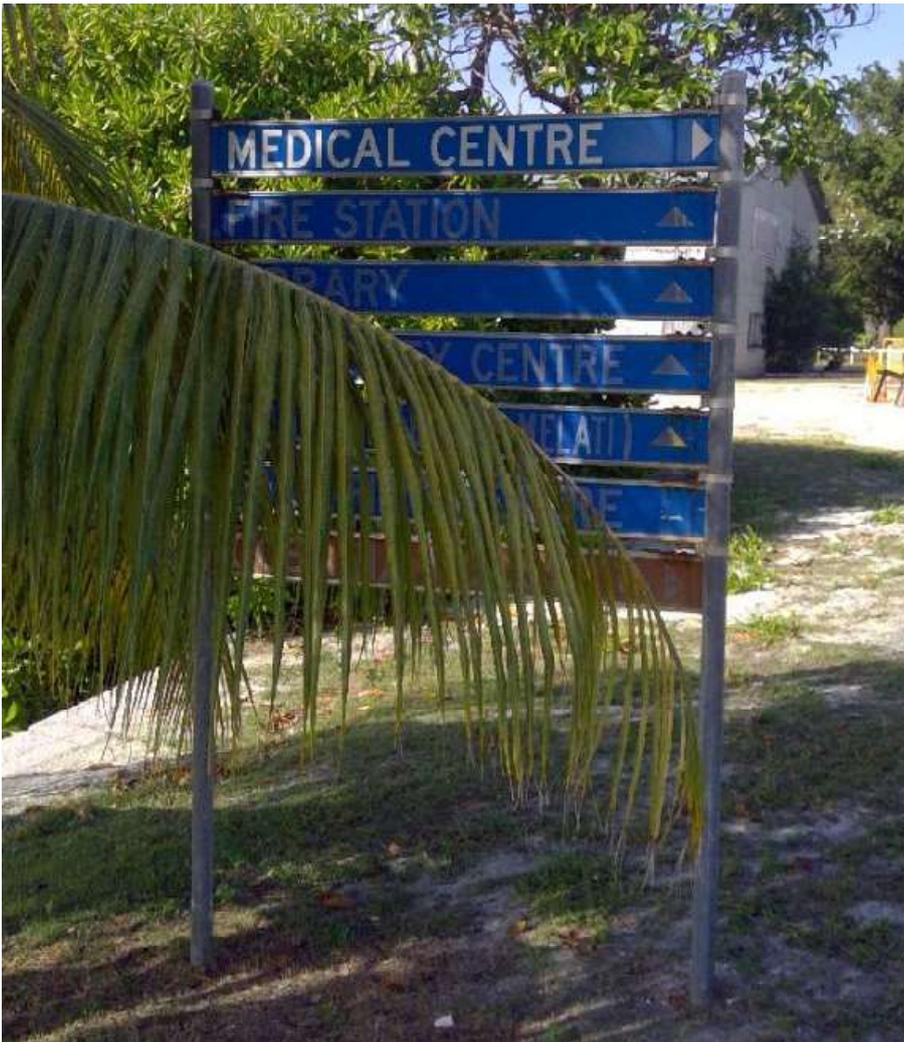
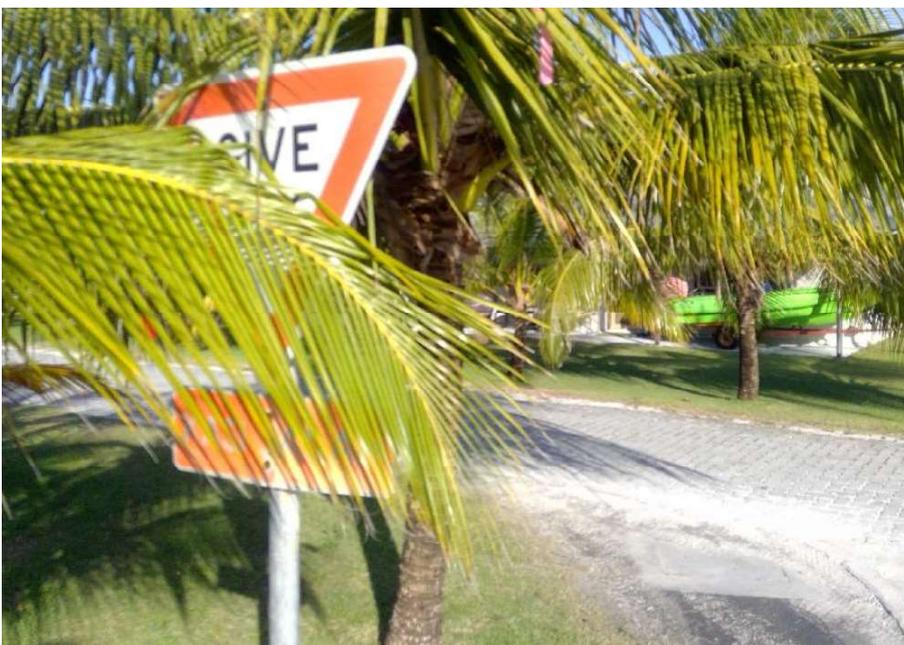
32. Overgrown vegetation obscuring signs is a general problem across the island and regular maintenance needs to be undertaken to ensure the intent of the sign is clear to road users. Vital information could be missed which could result in serious injury or the delay in finding essential services.

Recommendation is that a quarterly maintenance programme be established to deal with the vegetation.
