Cocos (Keeling) and Christmas Island, Sign & Pavement Marking Corrective Report

June 2019

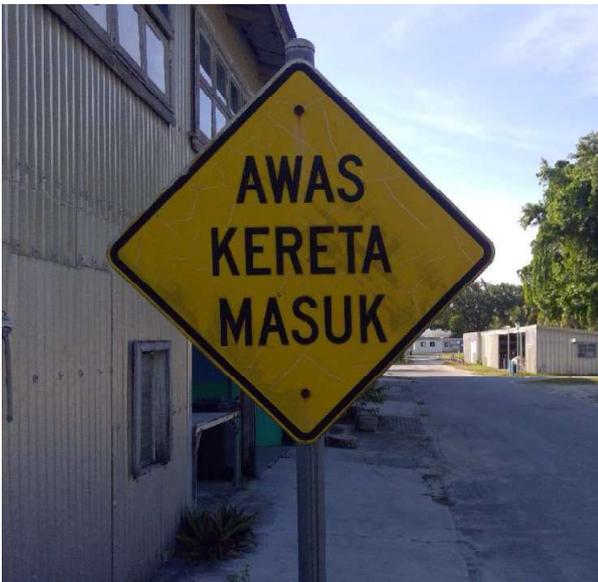
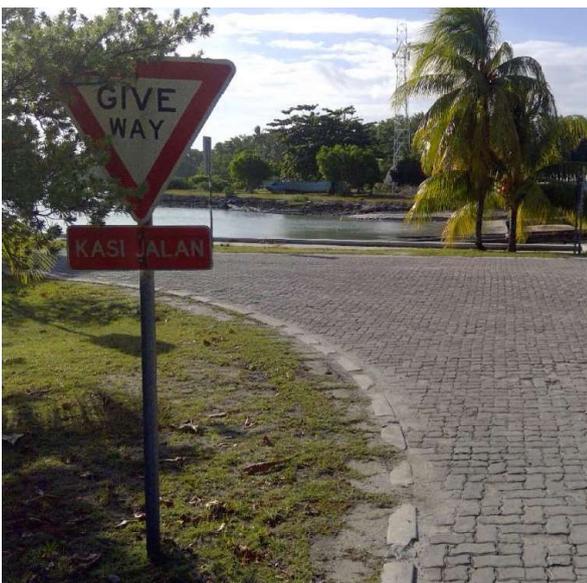
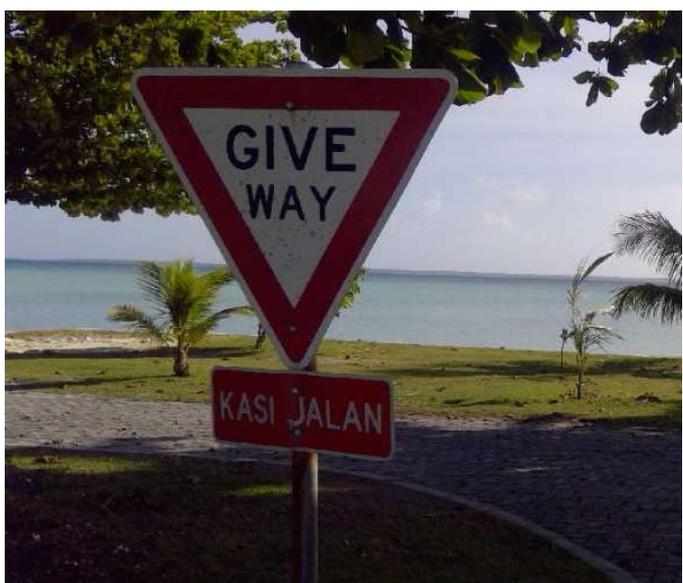
33. On Jin Melati just North of Jin Rel there is a Warning sign in Malay, whilst the intent of this sign may be obvious to Malay locals, it does not assist any non-Malay tourists to understand what the inherent risk is, which they are being exposed to at that location.

Additionally, in Austroads Guide to Traffic Management Part 10 it says (in part) “..... *The legend used on road signs in Australia and New Zealand must be in the English language. Information on signs is not to be duplicated in another language, as it is not practicable to accede to all such requests from the community. The replication of information in multiple languages would lead to confusing and ineffective signs that have excessive information.*”

The use of Malay on signs was wide spread across the island, in addition to the Warning sign, there were a number of tags beneath Give Way signs, these signs are superfluous even if the observer does not know English, Give Way signs follow an international shape convention so they can be recognised in every country regardless of language.

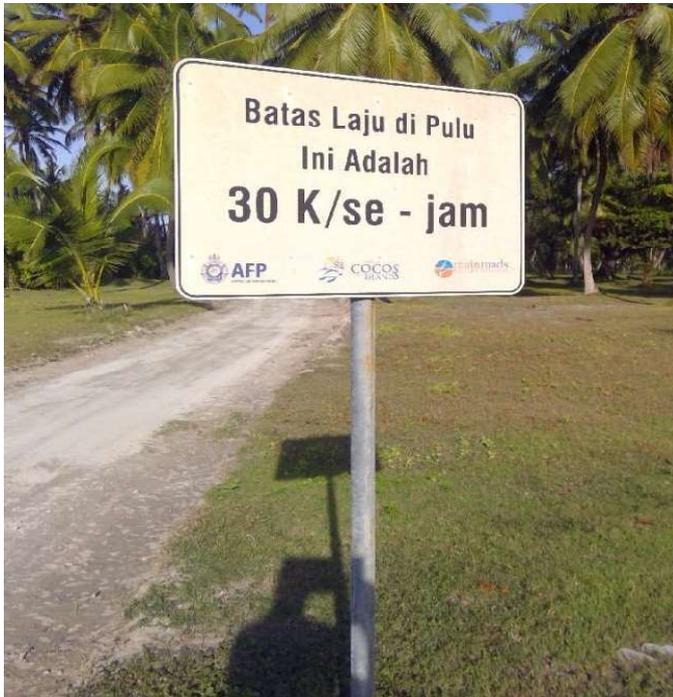
Of particular concern was a sign that it is presumed the intent of, is to advise that the maximum speed across the island is 30 Km/h which has the Australian Federal Police as well as Main Roads Western Australian insignias on them as endorsement. Recommendation is that this sign be removed.

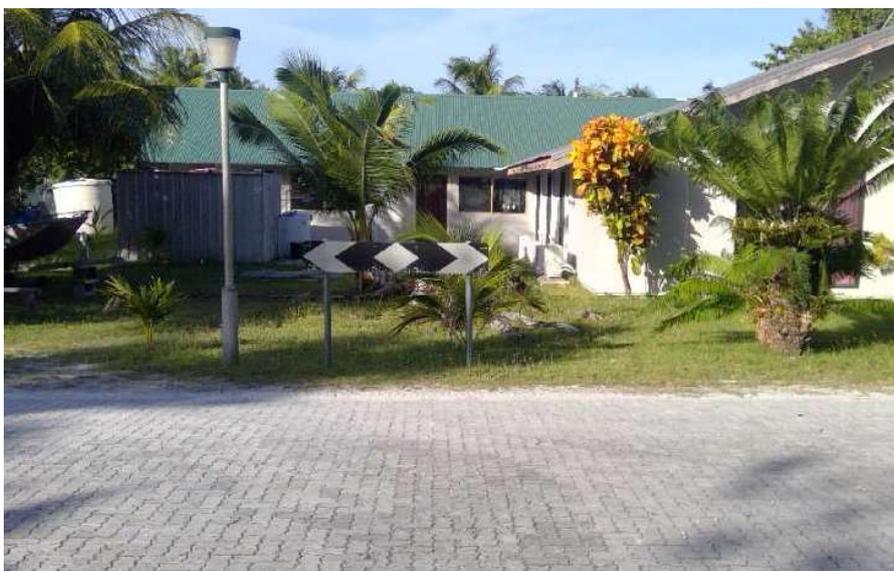
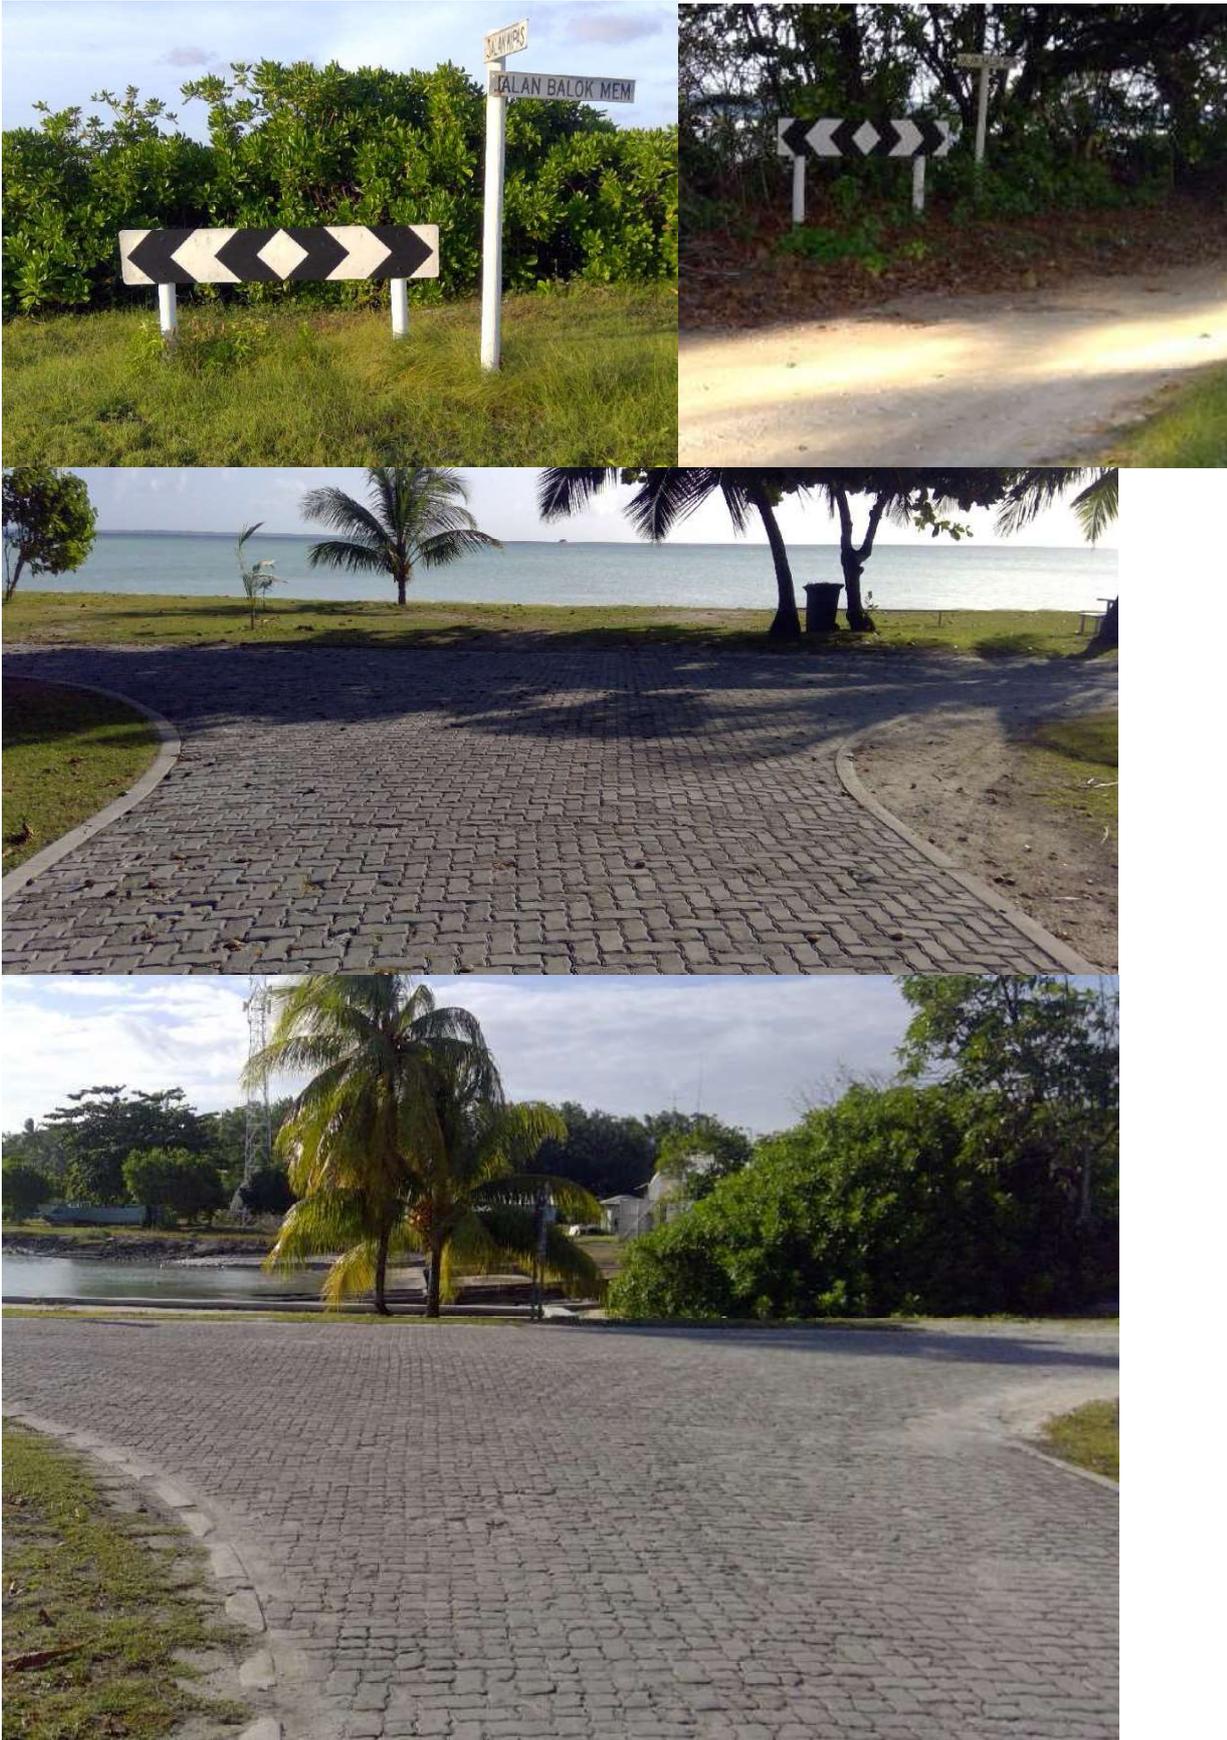
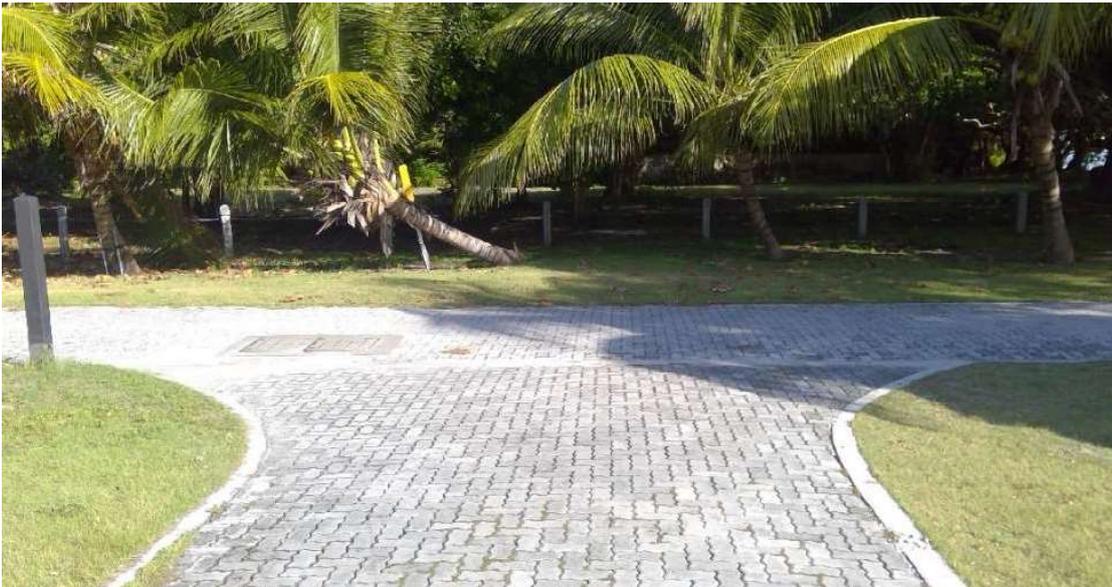
34. Hazard Marker application across the island was not consistent with Main Roads standards or consistent within its application across the island. Main Roads standard drawing for the application of Hazard Markers can be seen at [200831-0015](#). Hazard Markers are not required opposite T-junctions where there is a structure opposite, the structure demonstrates that the road does not continue. Hazard Markers are required at a T-junction where there isn't a structure, for example if there is bush, parkland, drop off etc. In those cases it should be a [MR-HM-2](#)

. Typically on the Island, a [MR-HM-1](#)

was used at T-junctions and often there wasn't a Hazard Marker when one should be installed.

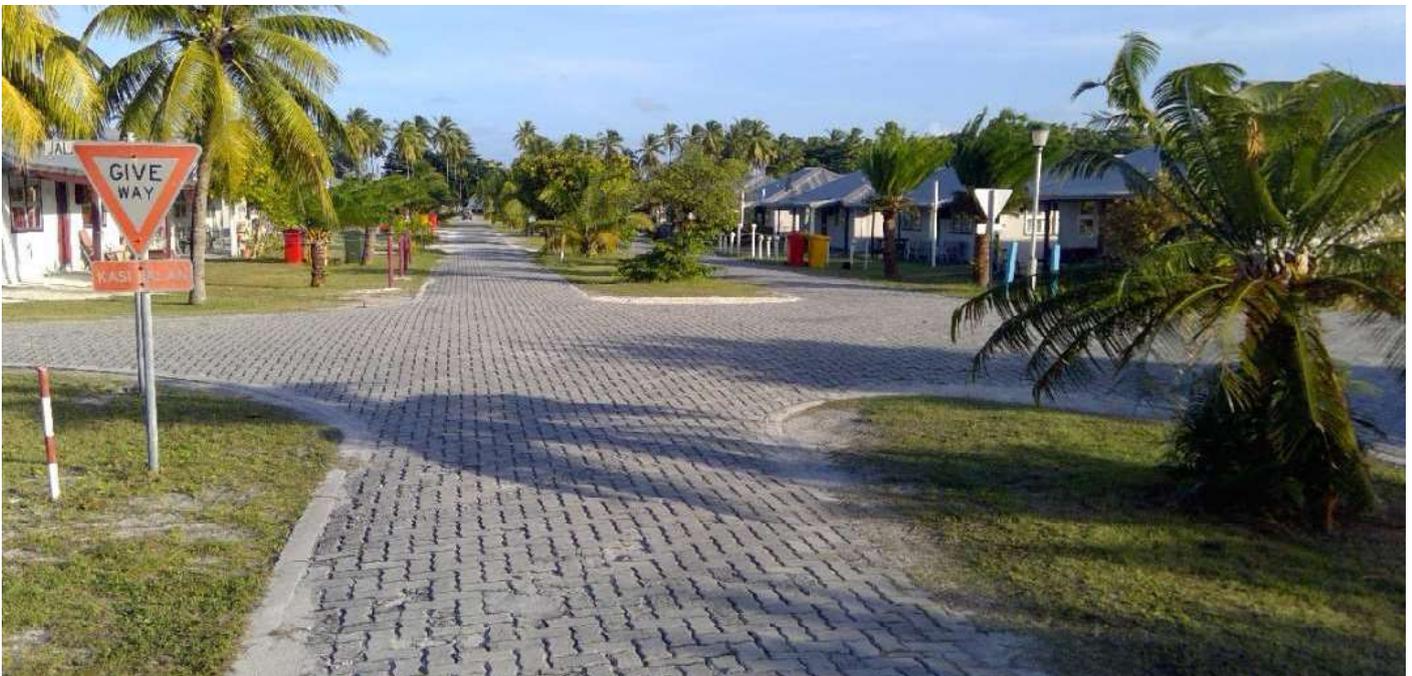
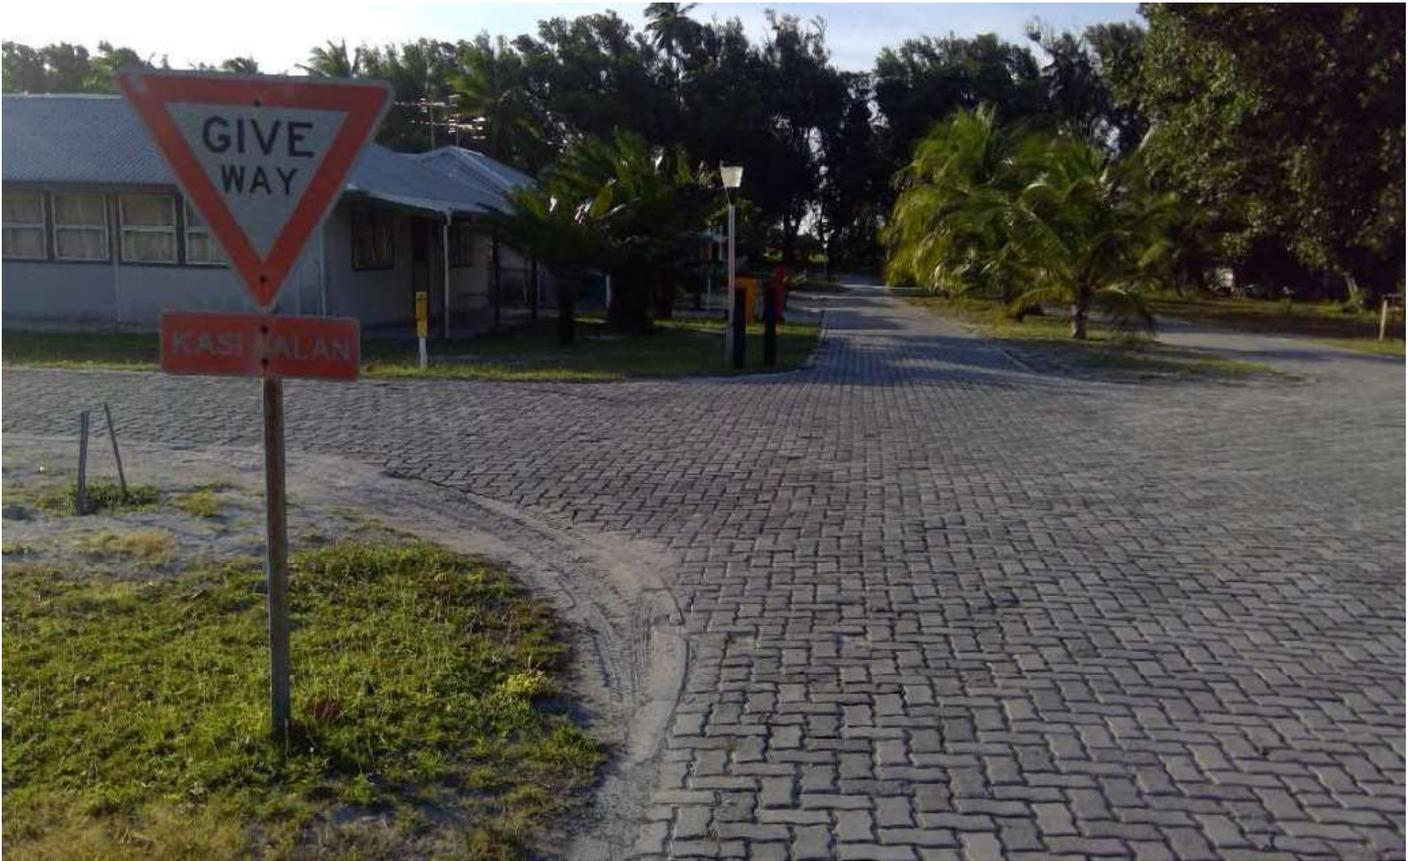
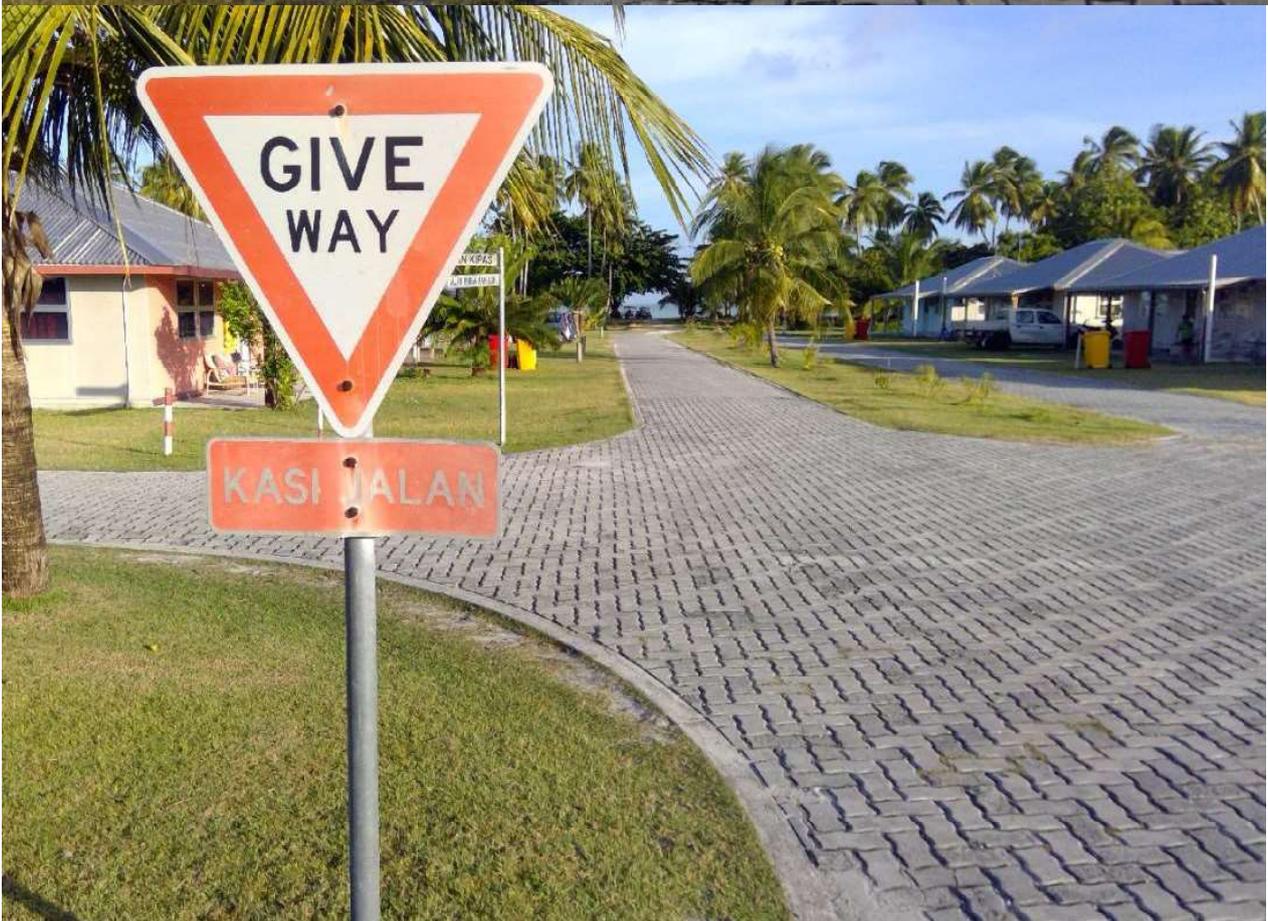
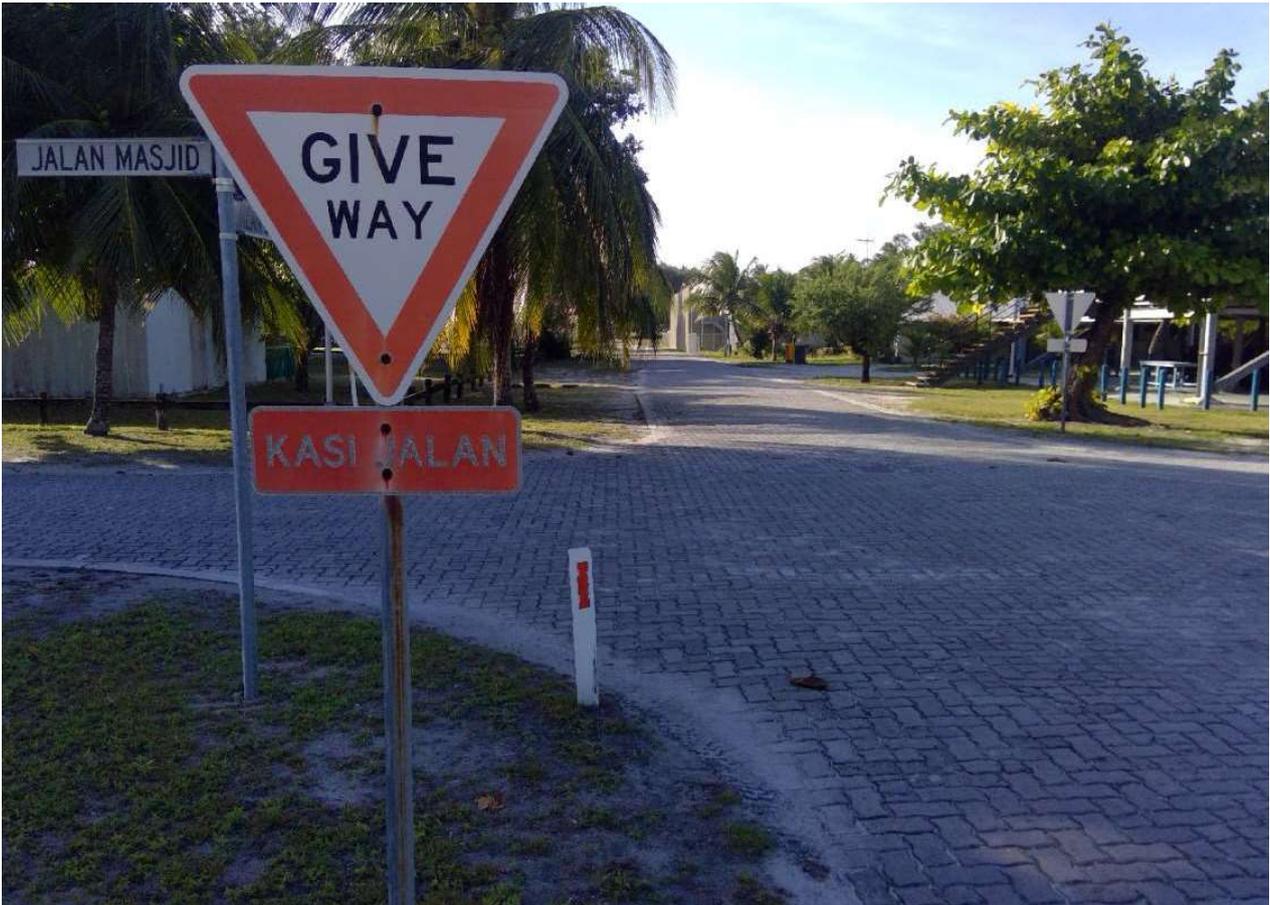
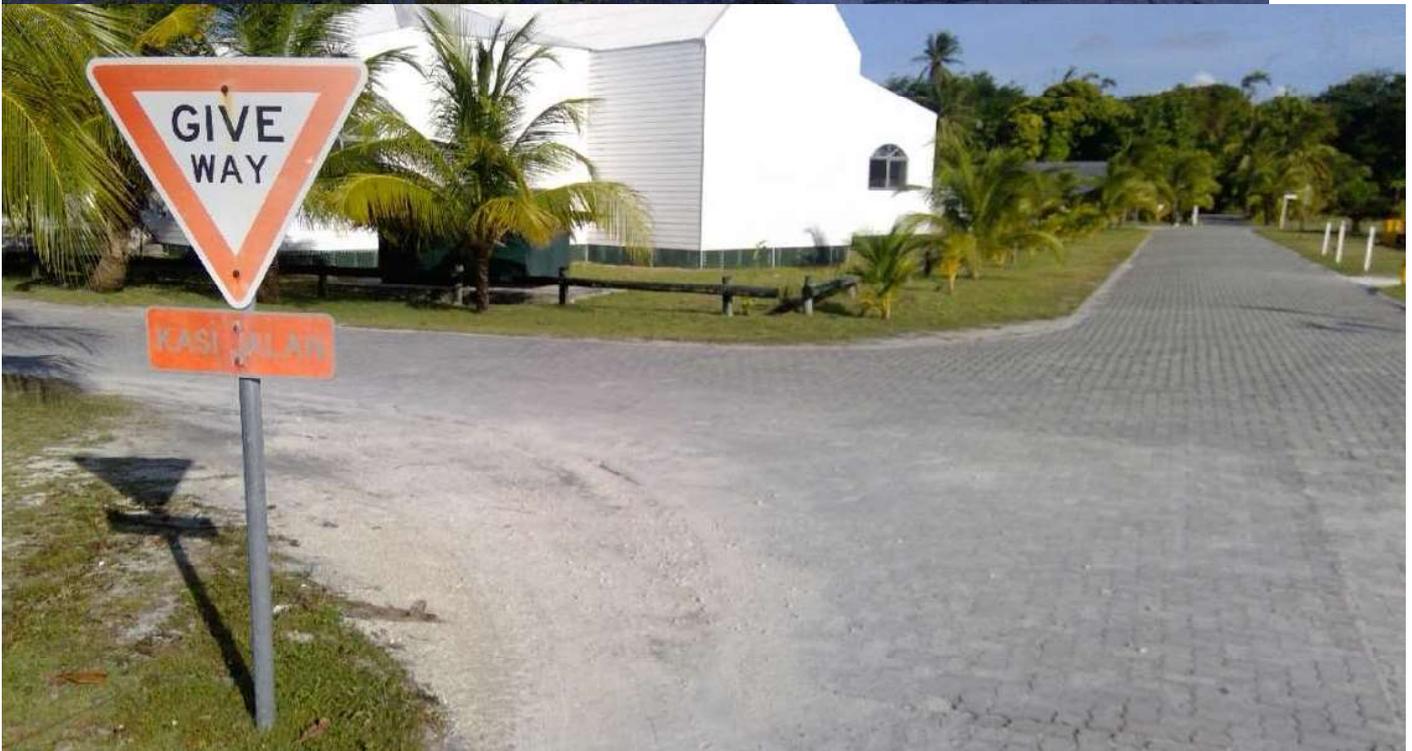
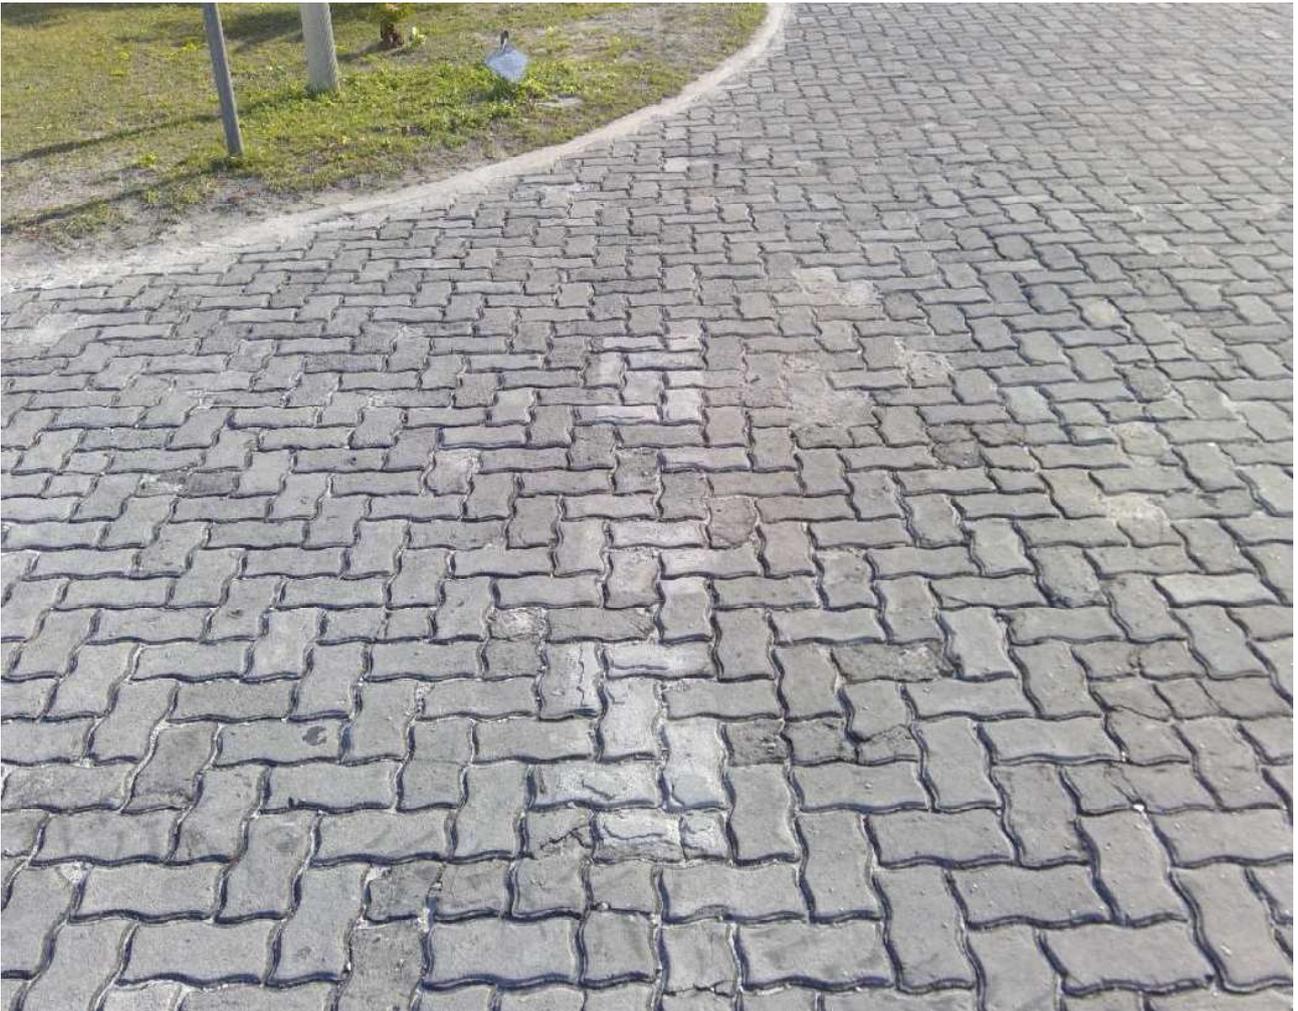
35. Give Way signs at four way intersections are required, there were no Stop Signs on the island and the warrant for Stop Sign was not met at any intersection.

At the majority of intersections Give Way signs were in poor condition with little or no reflectivity, and the associated pavement marking (Give Way Line) was typically so badly faded that it was difficult to make it out at all.

A comprehensive maintenance programme needs to commence to improve safety at four way intersections across the island.

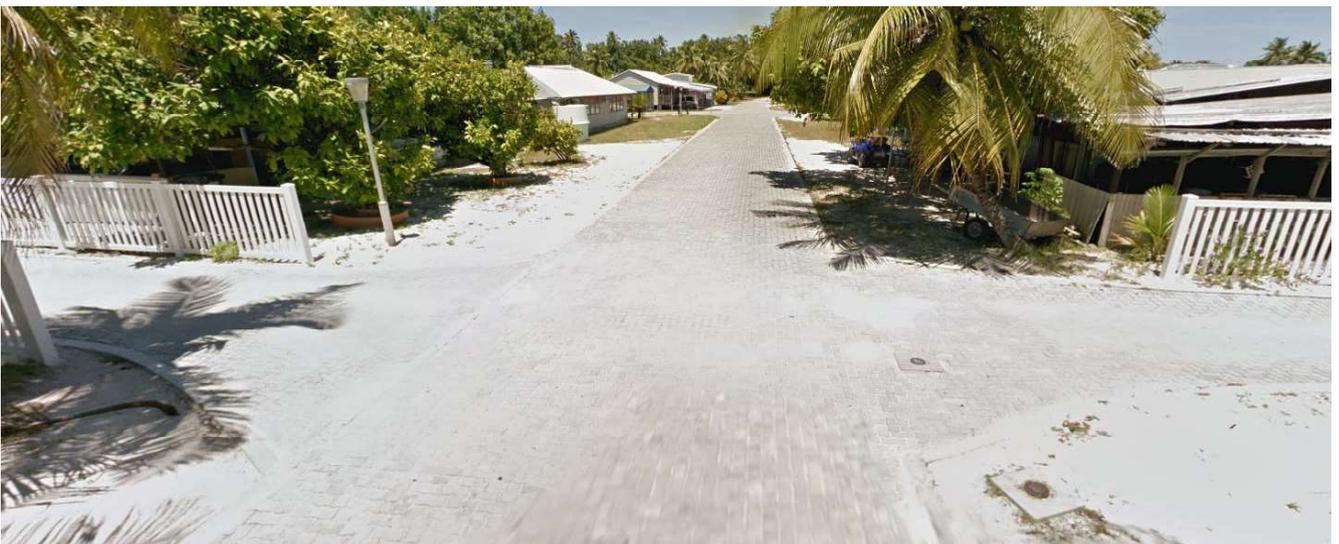
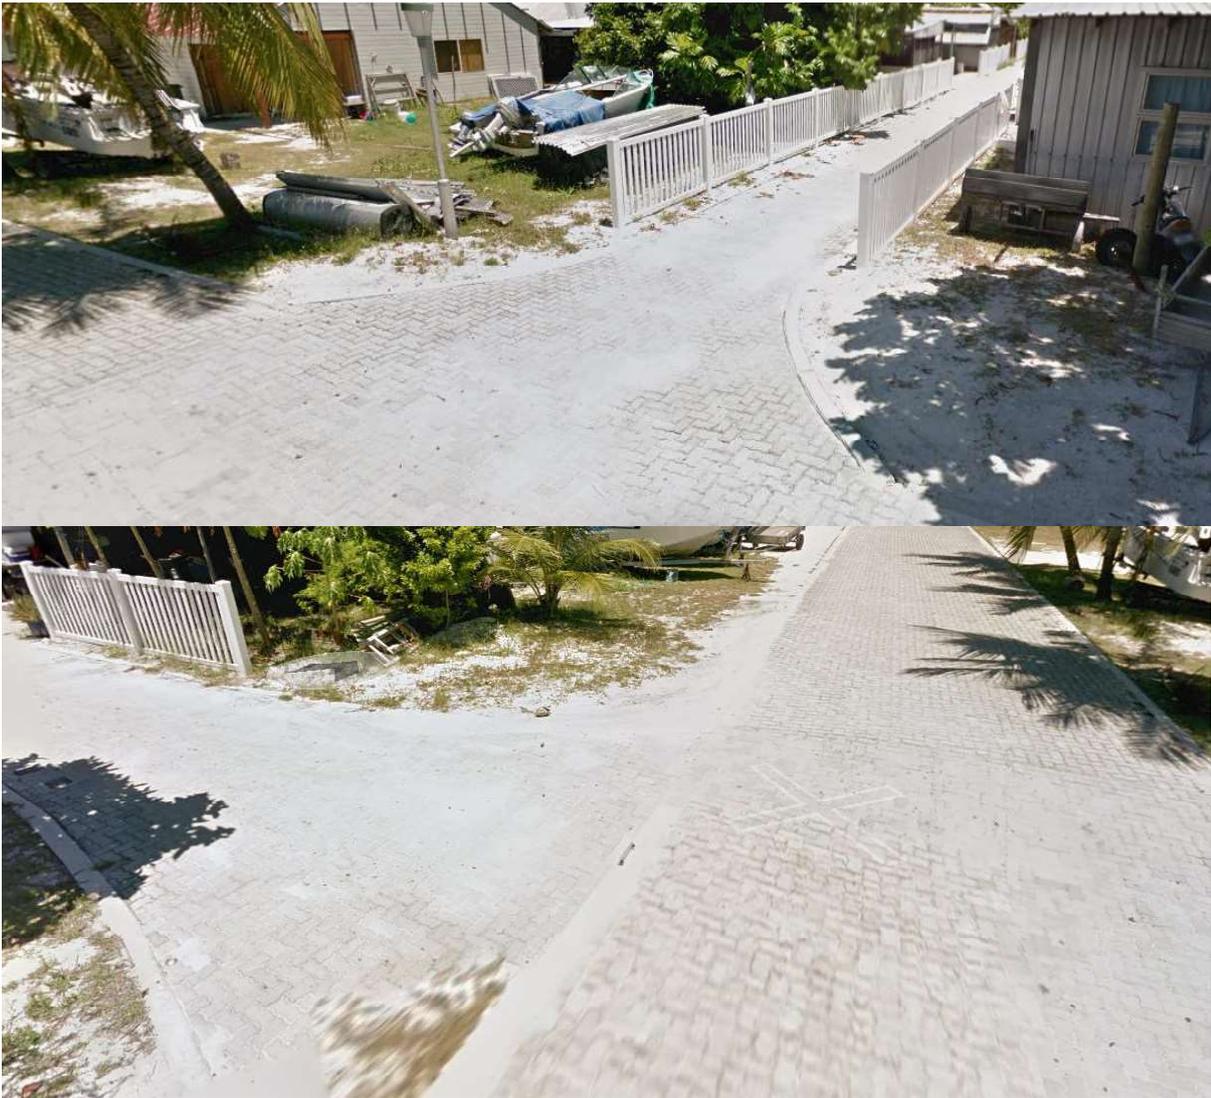
36. In addition to the 4 way intersections which are under Give Way control there are a series of laneways throughout the residential area allowing rear property access. These laneways form four way intersections with the surrounding road network but are not controlled. They need to have Give Way control placed on them to establish priority and improve road safety.

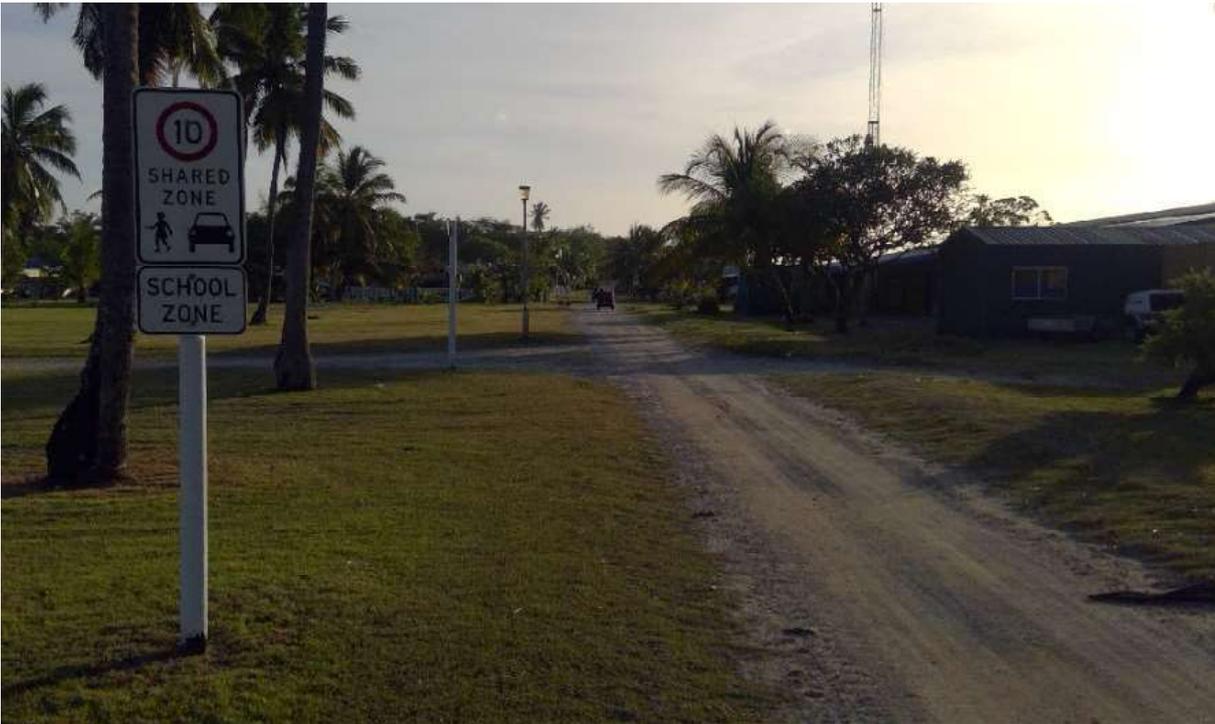
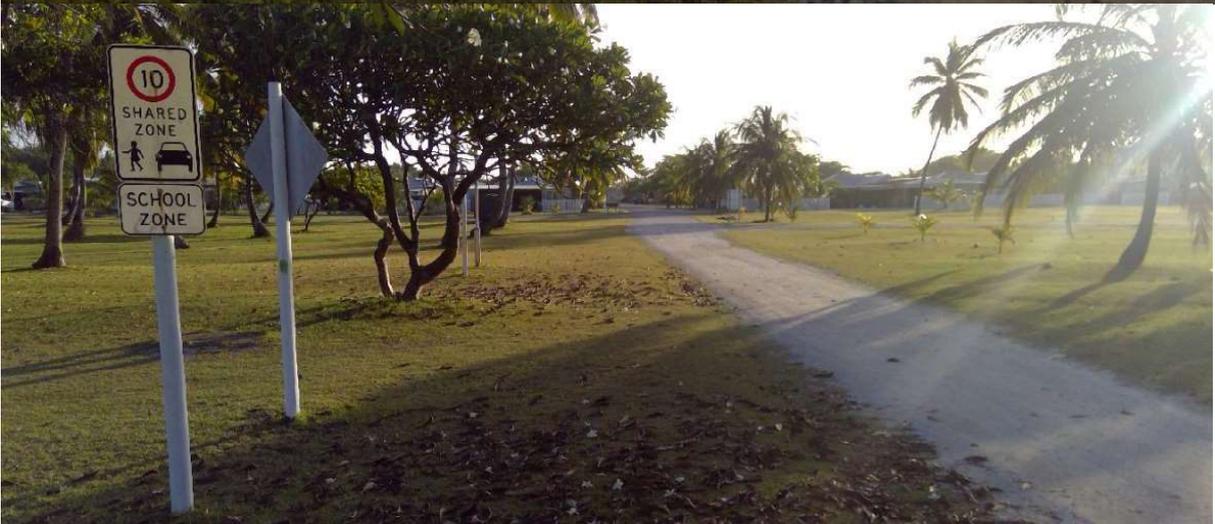
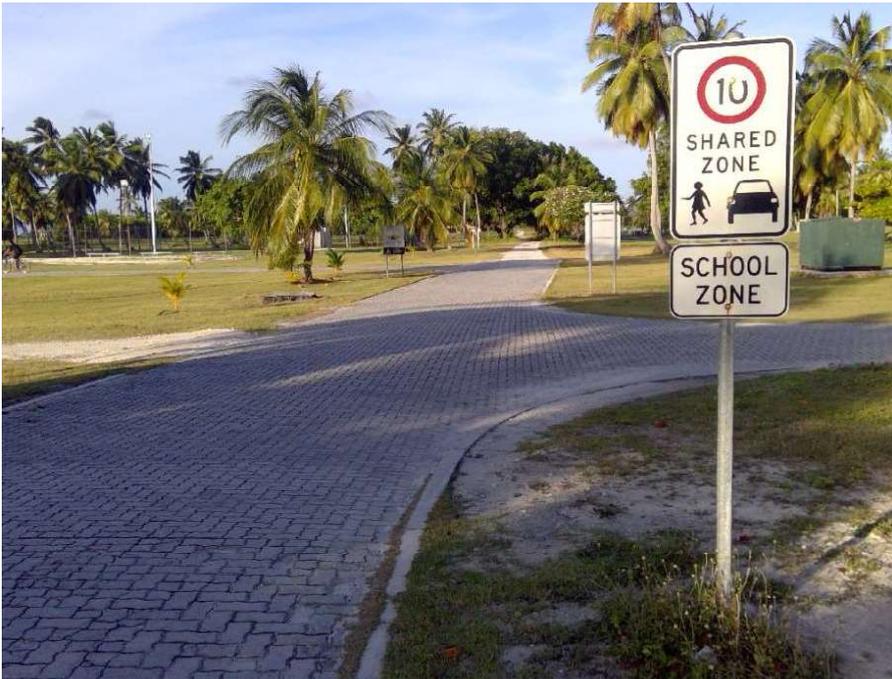
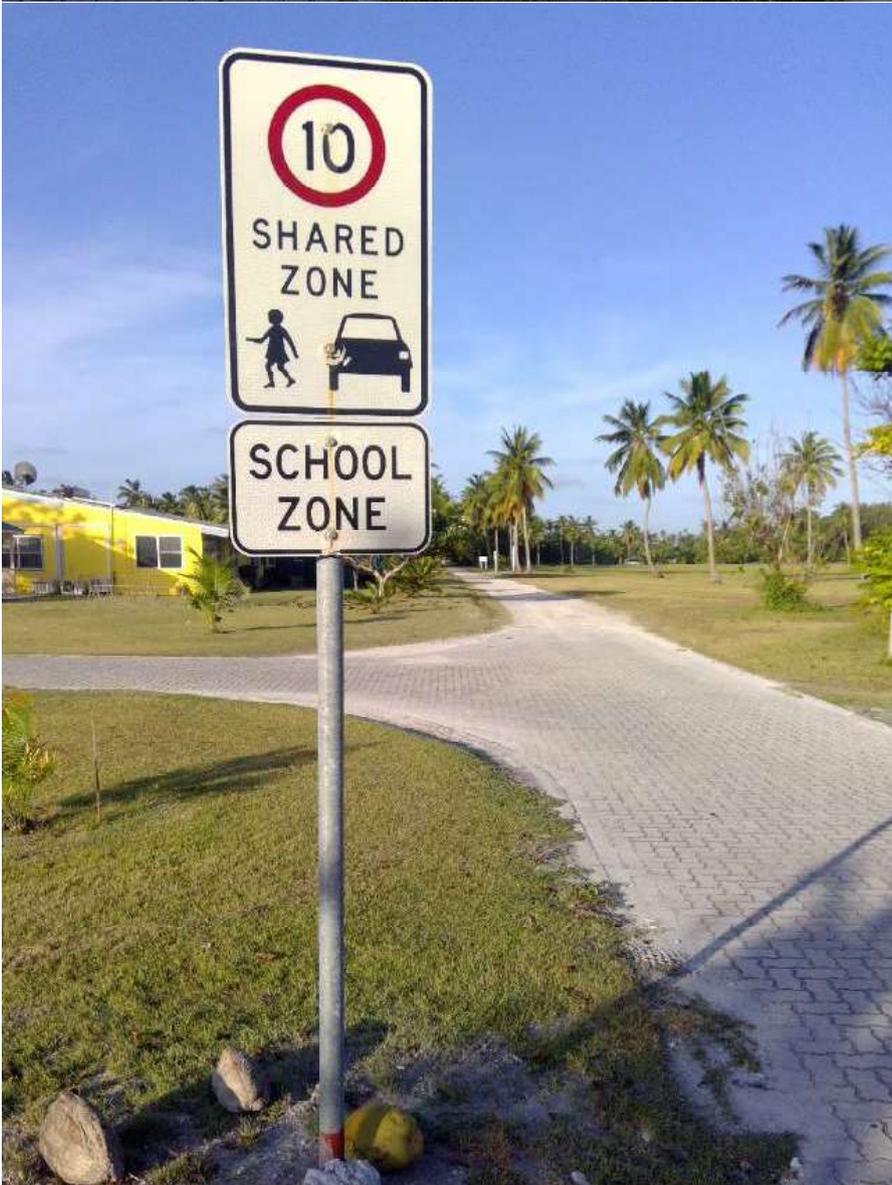
37. Surrounding the Cocos Island District High School there is a 10 Km/h Shared Zone being utilised as a School Zone. Whilst the intent to alert people that they are alongside a school and they need to be more vigilant is understandable, a Shared Zone is not the correct platform to do it from.

Within a Shared Zone, priority shifts from vehicles to pedestrians, and the impact is probably poorly understood within the community. This could lead to confusion and possible injury. Also some of the roads that are signposted as 10 Km/h Shared Zone are unsealed and unsealed roads cannot be speed zoned as their condition can change rapidly due to environmental factors.

Furthermore, given the type of vehicles on the island and their limited operational speed, a further reduction in speed zone for the school does not seem necessary. Installing SCHOOL ZONE signs around the school is completely acceptable to increase diligence from approaching motorists.

Recommendation would be to remove the 10 Km/h SHARED ZONE altogether, and utilise the standard School Zone as demonstrated within the Main Roads [Speed Zoning](#) policy.
