PROPOSED "HYDROponic SHADE HOUSE" COCOA FARM
MATHON ROAD, WEST ISLAND

PROPOSED "HYDROponic SHADE HOUSE" COCOA FARM
WEST ISLAND, MATHON RD.
SCALE: 1:200 DATE: 21/11/2023
DRAWN: B. BARNUM - FLS CONSTRUCTION
SHEET: 1 OF 2

SECTIONAL DETAILS
PROPOSED "HYDROPONIC SHADHOUSE COCOF FRAM"
WEST ISLAND, MAHON RD
SCALE: 1:100 DATE: 22/1/2023
DRAWN: Z BANLOW - BIS CONSTRUCTION
SHEET: 2 OF 2

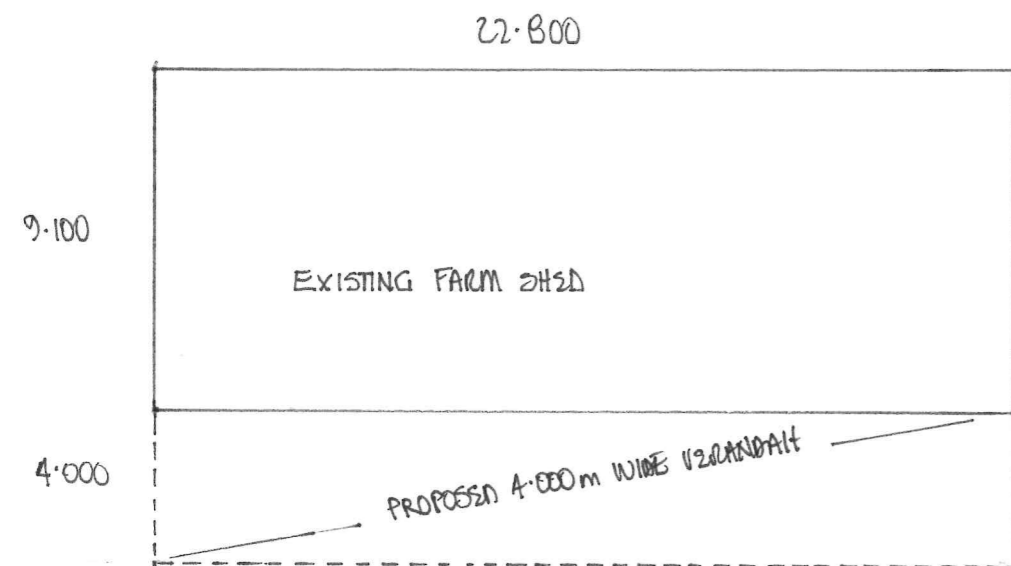
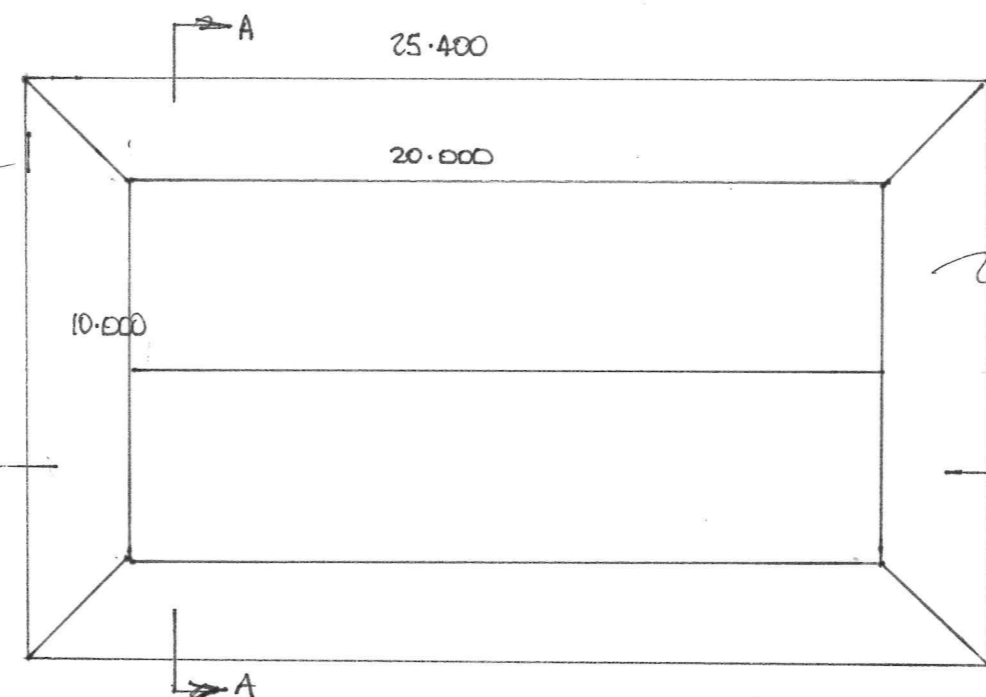
VERMIN PROOF ACCESS DOOR

TRANSLUCENT POLY CARBONATE TRIM BEZEL PROFILE ROOF CLADDING.

VERMIN PROOF SHADE CURTAIN & CORRUGATE SHEETING TO EXTERNAL FACE, ALL SIDES.
